Access Compliance Report

Public Rights-of-Way

(Island Curb Cuts)

Intersection ID: 5832	Main Street: N_TRYON_ST	Cross Street: KEN_HOFFMAN_DR	Location: E
ADA ID: 480569762C3E	Curb Cut Type: MedianRefuge2	Initial Pass/Fail: Fail	Overall Compliance: No
Codes/Mitigation Info/Possible Solution		Field Measurements/Component Compliance	
Severity Score: 25

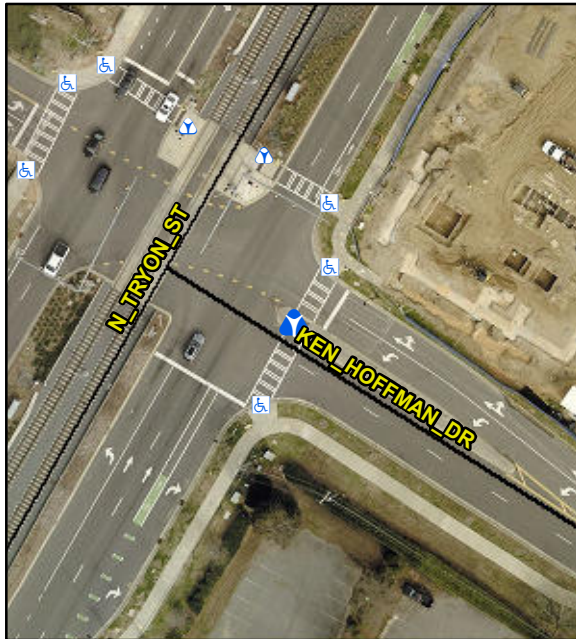
Compliance	Description	Data	Compliance	Description	Data
Yes	Refuge 1 Length (In)	48.0	N/A	Gutter 1 Ponding?	N/A
Yes	Refuge 1 Width (In)	96.0	N/A	Gutter 1 Lip Ht (In)	N/A
Yes	Refuge 1 Slope (%)	4.2	N/A	Gutter 1 Slope (%)	N/A
Yes	Refuge 1 X Slope (%)	0.2	N/A	Gutter 1 X Slope (%)	N/A
N/A	Painted X Walk1?	No	N/A	DWS 1 Provided?	N/A
N/A	X Walk 1 Direction	To NE	N/A	DWS 1 Contrast?	N/A
N/A	X Walk 1 Width (In)	N/A	N/A	DWS 1 Length (In)	N/A
N/A	Road 1 Slope (%)	0.9	N/A	DWS 1 Full Width?	N/A
N/A	Road 1 X Slope (%)	2.6	N/A	DWS 1 Offset (In)	N/A
Yes	Refuge 2 Length (In)	48.0	N/A	Gutter 2 Ponding?	N/A
Yes	Refuge 2 Width (In)	96.0	N/A	Gutter 2 Lip Ht (In)	N/A
No	Refuge 2 Slope (%)	10.4	N/A	Gutter 2 Slope (%)	N/A
Yes	Refuge 2 X Slope (%)	1.0	N/A	Gutter 2 X Slope (%)	N/A
N/A	Painted X Walk2?	No	N/A	DWS 2 Provided?	N/A
N/A	X Walk 2 Direction	To SW	N/A	DWS 2 Contrast?	N/A
N/A	X Walk 2 Width (In)	N/A	N/A	DWS 2 Length (In)	N/A

N/A	Road 2 Slope (%)	0.9	N/A	DWS 2 Full Width?	N/A
N/A	Road 2 X Slope (%)	1.5	N/A	DWS 2 Offset (In)	N/A
N/A	Refuge 3 Length (in)	N/A	N/A	Gutter 3 Ponding?	N/A
N/A	Refuge 3 Width (in)	N/A	N/A	Gutter 3 Lip Ht (in)	N/A
N/A	Refuge 3 Slope (%)	N/A	N/A	Gutter 3 Slope (%)	N/A
N/A	Refuge 3 XSlope (%)	N/A	N/A	Gutter 3 XSlope (%)	N/A
N/A	Painted X Walk3?	No	N/A	DWS 3 Provided?	N/A
N/A	X Walk 3 Direction	N/A	N/A	DWS 3 Contrast?	N/A
N/A	X Walk 3 Width (in)	N/A	N/A	DWS 3 Length (in)	N/A
N/A	Road 3 Slope (%)	N/A	N/A	DWS 3 Full Width?	N/A
N/A	Road 3 XSlope (%)	N/A	N/A	DWS 3 Offset (in)	N/A
Yes	Any Obstructions?	N/A	N/A	Storm Grate/Utility Hazard?	N/A
N/A	Obstruction Type		N/A	Storm Grate/Utility Type	
		N/A			N/A
N/A	Surface Condition	Good

Possible Solutions:

Remove & Replace Entire Refuge.
