Access Compliance Report

Public Rights-of-Way

(Island Curb Cuts)

Intersection ID: 14648	Main Street: EAST_BV	Cross Street: LENNOX_AV	Location: SE
ADA ID: 4C849A22BE11	Curb Cut Type: MedianRefuge2	Initial Pass/Fail: Pass	Overall Compliance: No
Severity Score: 10.25			
Codes/Mitigation Info/Possible Solution		Field Measurements/Component Compliance

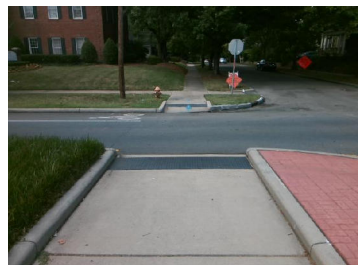
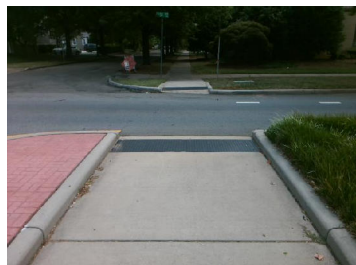
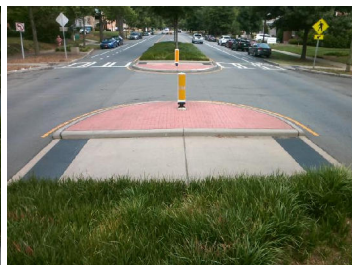
Compliance	Description	Data	Compliance	Description	Data
Yes	Refuge 1 Length (In)	114.5	Yes	Gutter 1 Ponding?	No
Yes	Refuge 1 Width (In)	97.0	Yes	Gutter 1 Lip Ht (In)	0.0
Yes	Refuge 1 Slope (%)	2.1	Yes	Gutter 1 Slope (%)	2.8
Yes	Refuge 1 X Slope (%)	0.9	Yes	Gutter 1 X Slope (%)	2.0
N/A	Painted X Walk1?	No	Yes	DWS 1 Provided?	Yes
N/A	X Walk 1 Direction	To SW	Yes	DWS 1 Contrast?	Yes
N/A	X Walk 1 Width (In)	N/A	Yes	DWS 1 Length (In)	24.5
N/A	Road 1 Slope (%)	1.7	Yes	DWS 1 Full Width?	Yes
N/A	Road 1 X Slope (%)	2.7	No	DWS 1 Offset (In)	7.0
Yes	Refuge 2 Length (In)	114.5	Yes	Gutter 2 Ponding?	No
Yes	Refuge 2 Width (In)	97.0	Yes	Gutter 2 Lip Ht (In)	0.0
Yes	Refuge 2 Slope (%)	3.8	No	Gutter 2 Slope (%)	7.3
Yes	Refuge 2 X Slope (%)	0.6	Yes	Gutter 2 X Slope (%)	1.5
N/A	Painted X Walk2?	No	Yes	DWS 2 Provided?	Yes
N/A	X Walk 2 Direction	To NE	Yes	DWS 2 Contrast?	Yes
N/A	X Walk 2 Width (In)	N/A	Yes	DWS 2 Length (In)	24.5

N/A	Road 2 Slope (%)	1.9	Yes	DWS 2 Full Width?	Yes
N/A	Road 2 X Slope (%)	3.0	No	DWS 2 Offset (In)	7.0
N/A	Refuge 3 Length (in)	N/A	N/A	Gutter 3 Ponding?	N/A
N/A	Refuge 3 Width (in)	N/A	N/A	Gutter 3 Lip Ht (in)	N/A
N/A	Refuge 3 Slope (%)	N/A	N/A	Gutter 3 Slope (%)	N/A
N/A	Refuge 3 XSlope (%)	N/A	N/A	Gutter 3 XSlope (%)	N/A
N/A	Painted X Walk3?	N/A	N/A	DWS 3 Provided?	N/A
N/A	X Walk 3 Direction	N/A	N/A	DWS 3 Contrast?	N/A
N/A	X Walk 3 Width (in)	N/A	N/A	DWS 3 Length (in)	N/A
N/A	Road 3 Slope (%)	N/A	N/A	DWS 3 Full Width?	N/A
N/A	Road 3 XSlope (%)	N/A	N/A	DWS 3 Offset (in)	N/A
Yes	Any Obstructions?	N/A	N/A	Storm Grate/Utility Hazard?	No
N/A	Obstruction Type		N/A	Storm Grate/Utility Type	
		N/A			N/A
N/A	Surface Condition	Good

Remove & Replace Detectable Warning System. Remove & Replace Gutter.
