Access Compliance Report

Public Rights-of-Way

(Island Curb Cuts)

Intersection ID: 17513	Main Street: PROVIDENCE_DR	Cross Street: PROVIDENCE_RD	Location: S
ADA ID: 4F519499A252	Curb Cut Type: MedianRefuge2	Initial Pass/Fail: Fail	Overall Compliance: No
Severity Score: 10			
Codes/Mitigation Info/Possible Solution		Field Measurements/Component Compliance

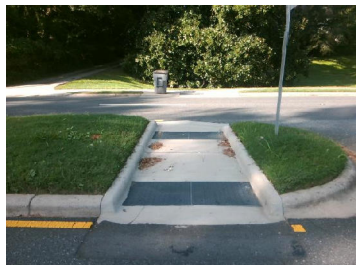
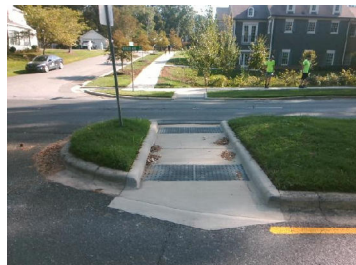
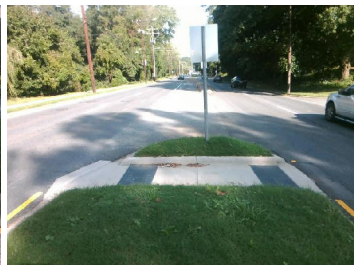
Compliance	Description	Data	Compliance	Description	Data
Yes	Refuge 1 Length (In)	80.0	N/A	Gutter 1 Ponding?	N/A
No	Refuge 1 Width (In)	59.0	N/A	Gutter 1 Lip Ht (In)	N/A
Yes	Refuge 1 Slope (%)	0.9	N/A	Gutter 1 Slope (%)	N/A
Yes	Refuge 1 X Slope (%)	3.6	N/A	Gutter 1 X Slope (%)	N/A
N/A	Painted X Walk1?	No	N/A	DWS 1 Provided?	N/A
N/A	X Walk 1 Direction	To E	N/A	DWS 1 Contrast?	N/A
N/A	X Walk 1 Width (In)	N/A	N/A	DWS 1 Length (In)	N/A
N/A	Road 1 Slope (%)	3.1	N/A	DWS 1 Full Width?	N/A
N/A	Road 1 X Slope (%)	1.7	N/A	DWS 1 Offset (In)	N/A
Yes	Refuge 2 Length (In)	80.0	N/A	Gutter 2 Ponding?	N/A
No	Refuge 2 Width (In)	59.0	N/A	Gutter 2 Lip Ht (In)	N/A
Yes	Refuge 2 Slope (%)	2.1	N/A	Gutter 2 Slope (%)	N/A
Yes	Refuge 2 X Slope (%)	4.3	N/A	Gutter 2 X Slope (%)	N/A
N/A	Painted X Walk2?	No	N/A	DWS 2 Provided?	N/A
N/A	X Walk 2 Direction	To W	N/A	DWS 2 Contrast?	N/A
N/A	X Walk 2 Width (In)	N/A	N/A	DWS 2 Length (In)	N/A

Possible Solutions:

Remove & Replace Entire Refuge.
