Access Compliance Report

Public Rights-of-Way

(Island Curb Cuts)

Intersection ID: N/A	Main Street: N/A	Cross Street: N/A	Location:	W
ADA ID: 50273B70EC01	Curb Cut Type: MedianRefuge2	Initial Pass/Fail: Fail	Overall Compliance: No	Severity Score: 25
Codes/Mitigation Info/Possible Solution		Field Measurements/Component Compliance

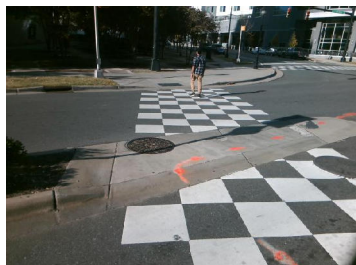
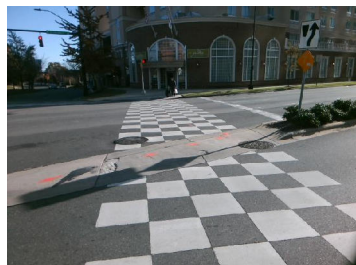
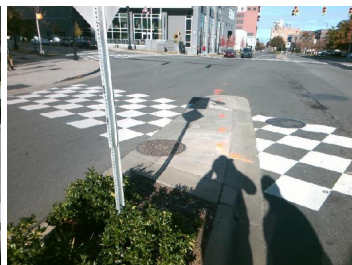
Compliance	Description	Data	Compliance	Description	Data
No	Refuge 1 Length (In)	15.0	N/A	Gutter 1 Ponding?	N/A
Yes	Refuge 1 Width (In)	181.0	N/A	Gutter 1 Lip Ht (In)	N/A
No	Refuge 1 Slope (%)	7.7	N/A	Gutter 1 Slope (%)	N/A
Yes	Refuge 1 X Slope (%)	0.6	N/A	Gutter 1 X Slope (%)	N/A
N/A	Painted X Walk1?	Yes	N/A	DWS 1 Provided?	N/A
N/A	X Walk 1 Direction	To S	N/A	DWS 1 Contrast?	N/A
N/A	X Walk 1 Width (In)	144.0	N/A	DWS 1 Length (In)	N/A
N/A	Road 1 Slope (%)	1.6	N/A	DWS 1 Full Width?	N/A
N/A	Road 1 X Slope (%)	0.6	N/A	DWS 1 Offset (In)	N/A
No	Refuge 2 Length (In)	15.0	N/A	Gutter 2 Ponding?	N/A
Yes	Refuge 2 Width (In)	181.0	N/A	Gutter 2 Lip Ht (In)	N/A
No	Refuge 2 Slope (%)	6.3	N/A	Gutter 2 Slope (%)	N/A
Yes	Refuge 2 X Slope (%)	0.0	N/A	Gutter 2 X Slope (%)	N/A
N/A	Painted X Walk2?	Yes	N/A	DWS 2 Provided?	N/A
N/A	X Walk 2 Direction	To N	N/A	DWS 2 Contrast?	N/A
N/A	X Walk 2 Width (In)	144.0	N/A	DWS 2 Length (In)	N/A

N/A	Road 2 Slope (%)	0.8	N/A	DWS 2 Full Width?	N/A
N/A	Road 2 X Slope (%)	0.8	N/A	DWS 2 Offset (In)	N/A
N/A	Refuge 3 Length (in)	N/A	N/A	Gutter 3 Ponding?	N/A
N/A	Refuge 3 Width (in)	N/A	N/A	Gutter 3 Lip Ht (in)	N/A
N/A	Refuge 3 Slope (%)	N/A	N/A	Gutter 3 Slope (%)	N/A
N/A	Refuge 3 XSlope (%)	N/A	N/A	Gutter 3 XSlope (%)	N/A
N/A	Painted X Walk3?	N/A	N/A	DWS 3 Provided?	N/A
N/A	X Walk 3 Direction	N/A	N/A	DWS 3 Contrast?	N/A
N/A	X Walk 3 Width (in)	N/A	N/A	DWS 3 Length (in)	N/A
N/A	Road 3 Slope (%)	N/A	N/A	DWS 3 Full Width?	N/A
N/A	Road 3 XSlope (%)	N/A	N/A	DWS 3 Offset (in)	N/A
Yes	Any Obstructions?	N/A	N/A	Storm Grate/Utility Hazard?	N/A
N/A	Obstruction Type		N/A	Storm Grate/Utility Type	
		N/A			N/A
N/A	Surface Condition	Good

Remove & Replace Entire Refuge.
