# Access Compliance Report

## Public Rights-of-Way

### (Island Curb Cuts)

Intersection ID: 48168	Main Street: PERIMETER_PY	Cross Street: NORTHLAKE_MALL_DR	Location: SE
ADA ID: 514D1961EA6A	Curb Cut Type: IslandRefuge2	Initial Pass/Fail: Fail	Overall Compliance: No
Severity Score: 8.75			
Codes/Mitigation Info/Possible Solution		Field Measurements/Component Compliance

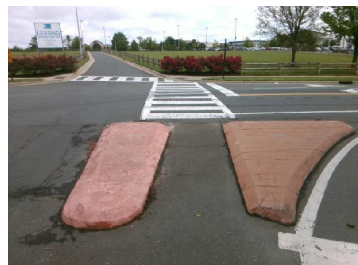
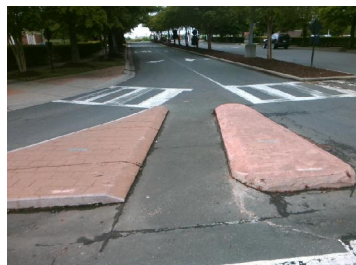
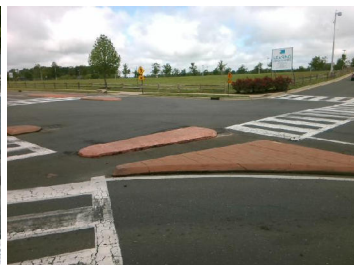
Compliance	Description	Data	Compliance	Description	Data
Yes	Refuge 1 Length (In)	88.0	N/A	Gutter 1 Ponding?	N/A
No	Refuge 1 Width (In)	52.0	N/A	Gutter 1 Lip Ht (In)	N/A
Yes	Refuge 1 Slope (%)	0.9	N/A	Gutter 1 Slope (%)	N/A
Yes	Refuge 1 X Slope (%)	2.3	N/A	Gutter 1 X Slope (%)	N/A
N/A	Painted X Walk1?	Yes	N/A	DWS 1 Provided?	N/A
N/A	X Walk 1 Direction	To N	N/A	DWS 1 Contrast?	N/A
N/A	X Walk 1 Width (In)	101.0	N/A	DWS 1 Length (In)	N/A
N/A	Road 1 Slope (%)	2.2	N/A	DWS 1 Full Width?	N/A
N/A	Road 1 X Slope (%)	3.2	N/A	DWS 1 Offset (In)	N/A
Yes	Refuge 2 Length (In)	88.0	N/A	Gutter 2 Ponding?	N/A
No	Refuge 2 Width (In)	52.0	N/A	Gutter 2 Lip Ht (In)	N/A
Yes	Refuge 2 Slope (%)	1.9	N/A	Gutter 2 Slope (%)	N/A
Yes	Refuge 2 X Slope (%)	1.1	N/A	Gutter 2 X Slope (%)	N/A
N/A	Painted X Walk2?	Yes	N/A	DWS 2 Provided?	N/A
N/A	X Walk 2 Direction	To S	N/A	DWS 2 Contrast?	N/A
N/A	X Walk 2 Width (In)	100.0	N/A	DWS 2 Length (In)	N/A

**Remove & Replace Entire Refuge.**
