Access Compliance Report

Public Rights-of-Way

(Island Curb Cuts)

Intersection ID: 10023892	Main Street: COMMUNITY_HOUSE_RD	Cross Street: N/A	Location: N
ADA ID: 51A3918AD8B7	Curb Cut Type: MedianRefuge2	Initial Pass/Fail: Fail	Overall Compliance: No
Codes/Mitigation Info/Possible Solution		Field Measurements/Component Compliance

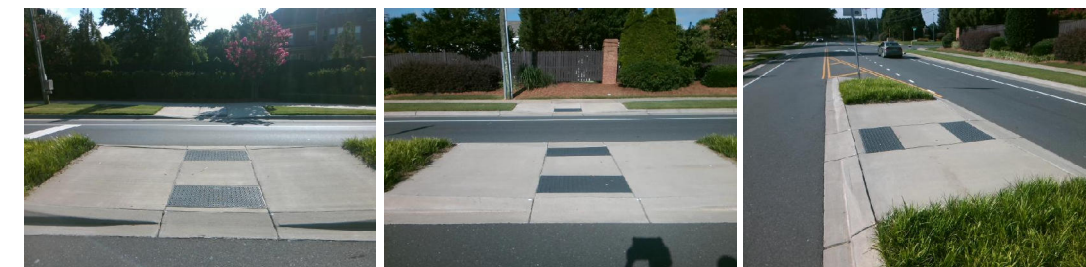
Compliance	Description	Data	Compliance	Description	Data
Yes	Refuge 1 Length (In)	54.0	N/A	Gutter 1 Ponding?	N/A
No	Refuge 1 Width (In)	47.0	N/A	Gutter 1 Lip Ht (In)	N/A
Yes	Refuge 1 Slope (%)	1.8	N/A	Gutter 1 Slope (%)	N/A
Yes	Refuge 1 X Slope (%)	1.7	N/A	Gutter 1 X Slope (%)	N/A
N/A	Painted X Walk1?	No	N/A	DWS 1 Provided?	N/A
N/A	X Walk 1 Direction	To NE	N/A	DWS 1 Contrast?	N/A
N/A	X Walk 1 Width (In)	N/A	N/A	DWS 1 Length (In)	N/A
N/A	Road 1 Slope (%)	1.6	N/A	DWS 1 Full Width?	N/A
N/A	Road 1 X Slope (%)	4.8	N/A	DWS 1 Offset (In)	N/A
Yes	Refuge 2 Length (In)	54.0	N/A	Gutter 2 Ponding?	N/A
No	Refuge 2 Width (In)	47.0	N/A	Gutter 2 Lip Ht (In)	N/A
Yes	Refuge 2 Slope (%)	2.6	N/A	Gutter 2 Slope (%)	N/A
Yes	Refuge 2 X Slope (%)	2.5	N/A	Gutter 2 X Slope (%)	N/A
N/A	Painted X Walk2?	No	N/A	DWS 2 Provided?	N/A
N/A	X Walk 2 Direction	To SW	N/A	DWS 2 Contrast?	N/A
N/A	X Walk 2 Width (In)	N/A	N/A	DWS 2 Length (In)	N/A

N/A	Road 2 Slope (%)	1.2	N/A	DWS 2 Full Width?	N/A
N/A	Road 2 X Slope (%)	4.3	N/A	DWS 2 Offset (In)	N/A
N/A	Refuge 3 Length (in)	N/A	N/A	Gutter 3 Ponding?	N/A
N/A	Refuge 3 Width (in)	N/A	N/A	Gutter 3 Lip Ht (in)	N/A
N/A	Refuge 3 Slope (%)	N/A	N/A	Gutter 3 Slope (%)	N/A
N/A	Refuge 3 XSlope (%)	N/A	N/A	Gutter 3 XSlope (%)	N/A
N/A	Painted X Walk3?	N/A	N/A	DWS 3 Provided?	N/A
N/A	X Walk 3 Direction	N/A	N/A	DWS 3 Contrast?	N/A
N/A	X Walk 3 Width (in)	N/A	N/A	DWS 3 Length (in)	N/A
N/A	Road 3 Slope (%)	N/A	N/A	DWS 3 Full Width?	N/A
N/A	Road 3 XSlope (%)	N/A	N/A	DWS 3 Offset (in)	N/A
Yes	Any Obstructions?	N/A	N/A	Storm Grate/Utility Hazard?	N/A
N/A	Obstruction Type		N/A	Storm Grate/Utility Type	
		N/A			N/A
N/A	Surface Condition	Good

Remove & Replace Entire Refuge.
