# Access Compliance Report

## Public Rights-of-Way

### (Island Curb Cuts)

Intersection ID: 52288	Main Street: STEELE_CREEK_RD	Cross Street: DIXIE_RIVER_RD	Location: E
ADA ID: 5394730F7DDE	Curb Cut Type: MedianRefuge2	Initial Pass/Fail: Fail	Overall Compliance: No
Codes/Mitigation Info/Possible Solution		Field Measurements/Component Compliance

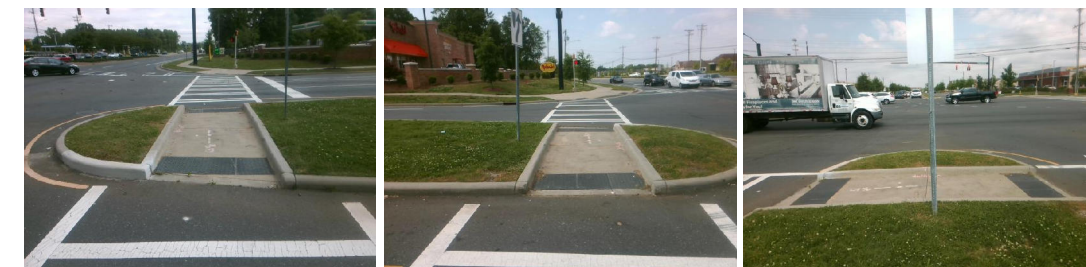
Compliance	Description	Data	Compliance	Description	Data
Yes	Refuge 1 Length (In)	62.5	N/A	Gutter 1 Ponding?	N/A
Yes	Refuge 1 Width (In)	68	N/A	Gutter 1 Lip Ht (In)	N/A
Yes	Refuge 1 Slope (%)	3.5	N/A	Gutter 1 Slope (%)	N/A
Yes	Refuge 1 X Slope (%)	1.2	N/A	Gutter 1 X Slope (%)	N/A
N/A	Painted X Walk1?	Yes	N/A	DWS 1 Provided?	N/A
N/A	X Walk 1 Direction	To SW	N/A	DWS 1 Contrast?	N/A
N/A	X Walk 1 Width (In)	112	N/A	DWS 1 Length (In)	N/A
N/A	Road 1 Slope (%)	0.6	N/A	DWS 1 Full Width?	N/A
N/A	Road 1 X Slope (%)	1.3	N/A	DWS 1 Offset (In)	N/A
Yes	Refuge 2 Length (In)	62.5	N/A	Gutter 2 Ponding?	N/A
Yes	Refuge 2 Width (In)	68	N/A	Gutter 2 Lip Ht (In)	N/A
Yes	Refuge 2 Slope (%)	2.1	N/A	Gutter 2 Slope (%)	N/A
Yes	Refuge 2 X Slope (%)	2.2	N/A	Gutter 2 X Slope (%)	N/A
N/A	Painted X Walk2?	Yes	N/A	DWS 2 Provided?	N/A
N/A	X Walk 2 Direction	To NE	N/A	DWS 2 Contrast?	N/A
N/A	X Walk 2 Width (In)	111	N/A	DWS 2 Length (In)	N/A

N/A	Road 2 Slope (%)	3.0	N/A	DWS 2 Full Width?	N/A
N/A	Road 2 X Slope (%)	0.4	N/A	DWS 2 Offset (In)	N/A
N/A	Refuge 3 Length (in)	N/A	N/A	Gutter 3 Ponding?	N/A
N/A	Refuge 3 Width (in)	N/A	N/A	Gutter 3 Lip Ht (in)	N/A
N/A	Refuge 3 Slope (%)	N/A	N/A	Gutter 3 Slope (%)	N/A
N/A	Refuge 3 XSlope (%)	N/A	N/A	Gutter 3 XSlope (%)	N/A
N/A	Painted X Walk3?	N/A	N/A	DWS 3 Provided?	N/A
N/A	X Walk 3 Direction	N/A	N/A	DWS 3 Contrast?	N/A
N/A	X Walk 3 Width (in)	N/A	N/A	DWS 3 Length (in)	N/A
N/A	Road 3 Slope (%)	N/A	N/A	DWS 3 Full Width?	N/A
N/A	Road 3 XSlope (%)	N/A	N/A	DWS 3 Offset (in)	N/A
Yes	Any Obstructions?	N/A	N/A	Storm Grate/Utility Hazard?	N/A
N/A	Obstruction Type		N/A	Storm Grate/Utility Type	
		N/A			N/A
N/A	Surface Condition	Good

**Remove & Replace Entire Refuge.**
