Access Compliance Report

Public Rights-of-Way

(Island Curb Cuts)

Intersection ID: 53534	Main Street: N_JOSH_BIRMINGHAM_PY	Cross Street: WILKINSON_BV	Location: NW
ADA ID: 53AAFA15ECE9	Curb Cut Type: IslandRefuge3	Initial Pass/Fail: Fail	Overall Compliance: No
		Severity Score: 36.25

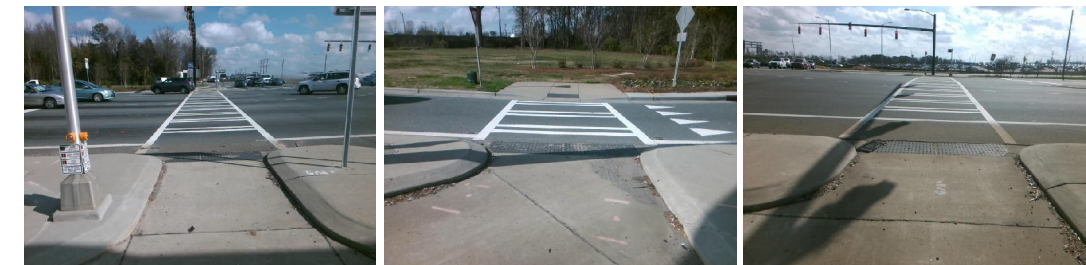
Compliance	Description	Data	Compliance	Description	Data
Yes	Refuge 1 Length (In)	117.0	N/A	Gutter 1 Ponding?	N/A
Yes	Refuge 1 Width (In)	72.0	N/A	Gutter 1 Lip Ht (In)	N/A
Yes	Refuge 1 Slope (%)	0.7	N/A	Gutter 1 Slope (%)	N/A
Yes	Refuge 1 X Slope (%)	2.5	N/A	Gutter 1 X Slope (%)	N/A
N/A	Painted X Walk1?	Yes	N/A	DWS 1 Provided?	N/A
N/A	X Walk 1 Direction	To E	N/A	DWS 1 Contrast?	N/A
N/A	X Walk 1 Width (In)	111.0	N/A	DWS 1 Length (In)	N/A
N/A	Road 1 Slope (%)	1.3	N/A	DWS 1 Full Width?	N/A
N/A	Road 1 X Slope (%)	0.9	N/A	DWS 1 Offset (In)	N/A
Yes	Refuge 2 Length (In)	47.0	N/A	Gutter 2 Ponding?	N/A
Yes	Refuge 2 Width (In)	90.0	N/A	Gutter 2 Lip Ht (In)	N/A
Yes	Refuge 2 Slope (%)	1.0	N/A	Gutter 2 Slope (%)	N/A
Yes	Refuge 2 X Slope (%)	1.7	N/A	Gutter 2 X Slope (%)	N/A
N/A	Painted X Walk2?	Yes	N/A	DWS 2 Provided?	N/A
N/A	X Walk 2 Direction	To W	N/A	DWS 2 Contrast?	N/A
N/A	X Walk 2 Width (In)	111.0	N/A	DWS 2 Length (In)	N/A

N/A	Road 2 Slope (%)	0.3	N/A	DWS 2 Full Width?	N/A
N/A	Road 2 X Slope (%)	3.7	N/A	DWS 2 Offset (In)	N/A
Yes	Refuge 3 Length (in)	95.0	N/A	Gutter 3 Ponding?	N/A
Yes	Refuge 3 Width (in)	95.0	N/A	Gutter 3 Lip Ht (in)	N/A
Yes	Refuge 3 Slope (%)	3.9	N/A	Gutter 3 Slope (%)	N/A
Yes	Refuge 3 XSlope (%)	0.1	N/A	Gutter 3 XSlope (%)	N/A
N/A	Painted X Walk3?	Yes	N/A	DWS 3 Provided?	N/A
N/A	X Walk 3 Direction	To S	N/A	DWS 3 Contrast?	N/A
N/A	X Walk 3 Width (in)	111.0	N/A	DWS 3 Length (in)	N/A
N/A	Road 3 Slope (%)	0.2	N/A	DWS 3 Full Width?	N/A
N/A	Road 3 XSlope (%)	1.9	N/A	DWS 3 Offset (in)	N/A
Yes	Any Obstructions?	N/A	N/A	Storm Grate/Utility Hazard?	N/A
N/A	Obstruction Type		N/A	Storm Grate/Utility Type	
		N/A			N/A
N/A	Surface Condition	Good

Remove & Replace Entire Refuge.
