Access Compliance Report

Public Rights-of-Way

(Island Curb Cuts)

Intersection ID: 10020719	Main Street: BEATTIES_FORD_RD	Cross Street: N/A	Location: N
ADA ID: 542C98C72BCF	Curb Cut Type: MedianRefuge2	Initial Pass/Fail: Pass	Overall Compliance: No
Codes/Mitigation Info/Possible Solution		Field Measurements/Component Compliance

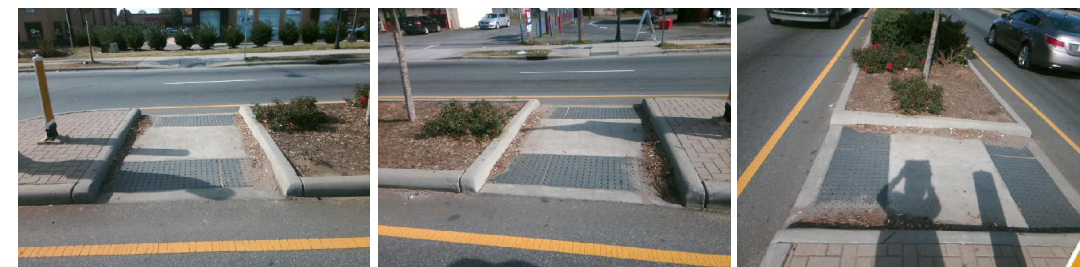
Compliance	Description	Data	Compliance	Description	Data
Yes	Refuge 1 Length (In)	54.5	Yes	Gutter 1 Ponding?	No
Yes	Refuge 1 Width (In)	71.5	Yes	Gutter 1 Lip Ht (In)	0.0
Yes	Refuge 1 Slope (%)	3.4	Yes	Gutter 1 Slope (%)	4.1
Yes	Refuge 1 X Slope (%)	0.6	Yes	Gutter 1 X Slope (%)	0.7
N/A	Painted X Walk1?	No	Yes	DWS 1 Provided?	Yes
N/A	X Walk 1 Direction	To W	Yes	DWS 1 Contrast?	Yes
N/A	X Walk 1 Width (In)	N/A	Yes	DWS 1 Length (In)	24.0
N/A	Road 1 Slope (%)	0.9	Yes	DWS 1 Full Width?	Yes
N/A	Road 1 X Slope (%)	2.6	No	DWS 1 Offset (In)	7.0
Yes	Refuge 2 Length (In)	54.5	Yes	Gutter 2 Ponding?	N/A
Yes	Refuge 2 Width (In)	71.5	Yes	Gutter 2 Lip Ht (In)	0.0
Yes	Refuge 2 Slope (%)	2.9	Yes	Gutter 2 Slope (%)	1.2
Yes	Refuge 2 X Slope (%)	1.1	Yes	Gutter 2 X Slope (%)	0.3
N/A	Painted X Walk2?	No	Yes	DWS 2 Provided?	Yes
N/A	X Walk 2 Direction	To E	Yes	DWS 2 Contrast?	Yes
N/A	X Walk 2 Width (In)	N/A	Yes	DWS 2 Length (In)	24.0

N/A	Road 2 Slope (%)	0.1	Yes	DWS 2 Full Width?	Yes
N/A	Road 2 X Slope (%)	3.8	No	DWS 2 Offset (In)	7.0
N/A	Refuge 3 Length (in)	N/A	N/A	Gutter 3 Ponding?	N/A
N/A	Refuge 3 Width (in)	N/A	N/A	Gutter 3 Lip Ht (in)	N/A
N/A	Refuge 3 Slope (%)	N/A	N/A	Gutter 3 Slope (%)	N/A
N/A	Refuge 3 XSlope (%)	N/A	N/A	Gutter 3 XSlope (%)	N/A
N/A	Painted X Walk3?	N/A	N/A	DWS 3 Provided?	N/A
N/A	X Walk 3 Direction	N/A	N/A	DWS 3 Contrast?	N/A
N/A	X Walk 3 Width (in)	N/A	N/A	DWS 3 Length (in)	N/A
N/A	Road 3 Slope (%)	N/A	N/A	DWS 3 Full Width?	N/A
N/A	Road 3 XSlope (%)	N/A	N/A	DWS 3 Offset (in)	N/A
Yes	Any Obstructions?	No	N/A	Storm Grate/Utility Hazard?	No
N/A	Obstruction Type		N/A	Storm Grate/Utility Type	
		N/A			N/A
N/A	Surface Condition	Good

Possible Solutions:

Remove & Replace Detectable Warning System.
