Access Compliance Report

Public Rights-of-Way

(Island Curb Cuts)

Intersection ID: 7770	Main Street: E_ARROWHEAD_DR	Cross Street: N_TRYON_ST	Location:	S
ADA ID: 548F67DDC6D8	Curb Cut Type: MedianRefuge2	Initial Pass/Fail: Pass	Overall Compliance: No	Severity Score: 15

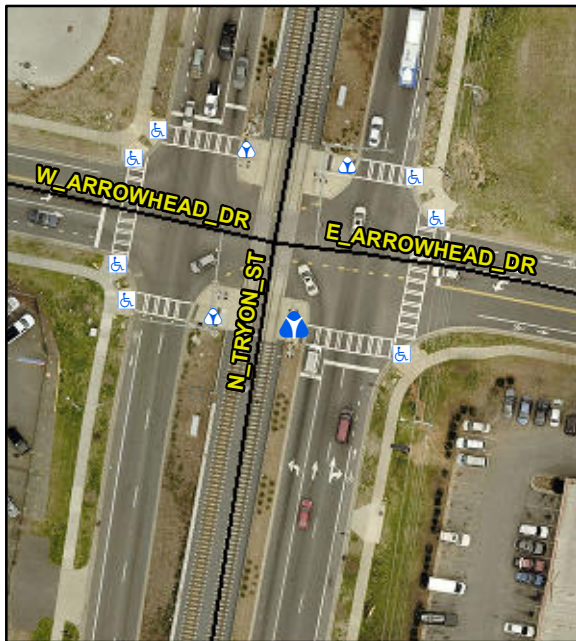
Compliance	Description	Data	Compliance	Description	Data
Yes	Refuge 1 Length (In)	48.0	Yes	Gutter 1 Ponding?	No
Yes	Refuge 1 Width (In)	121.0	No	Gutter 1 Lip Ht (In)	0.75
Yes	Refuge 1 Slope (%)	0.4	Yes	Gutter 1 Slope (%)	0.7
Yes	Refuge 1 X Slope (%)	0.1	Yes	Gutter 1 X Slope (%)	0.4
N/A	Painted X Walk1?	Yes	Yes	DWS 1 Provided?	Yes
N/A	X Walk 1 Direction	To E	Yes	DWS 1 Contrast?	Yes
N/A	X Walk 1 Width (In)	122.0	Yes	DWS 1 Length (In)	24.0
N/A	Road 1 Slope (%)	0.0	Yes	DWS 1 Full Width?	Yes
N/A	Road 1 X Slope (%)	1.6	Yes	DWS 1 Offset (In)	1.0
Yes	Refuge 2 Length (In)	48.0	Yes	Gutter 2 Ponding?	No
Yes	Refuge 2 Width (In)	121.0	Yes	Gutter 2 Lip Ht (In)	0.0
Yes	Refuge 2 Slope (%)	0.5	Yes	Gutter 2 Slope (%)	0.9
Yes	Refuge 2 X Slope (%)	0.6	Yes	Gutter 2 X Slope (%)	0.1
N/A	Painted X Walk2?	No	Yes	DWS 2 Provided?	Yes
N/A	X Walk 2 Direction	To W	Yes	DWS 2 Contrast?	Yes
N/A	X Walk 2 Width (In)	N/A	Yes	DWS 2 Length (In)	24.0

Grind Gutter Lip.
