Access Compliance Report

Public Rights-of-Way

(Island Curb Cuts)

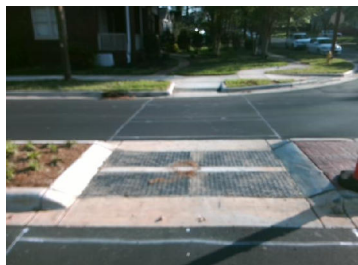
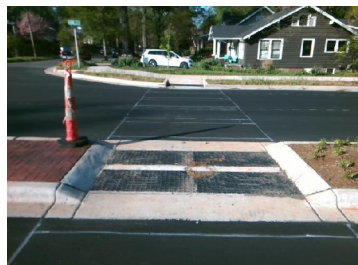
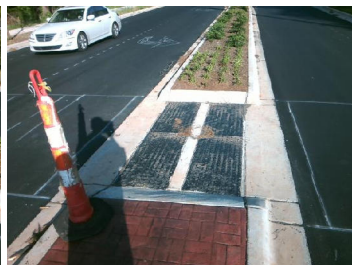
Intersection ID: 11231	Main Street: W_4TH_ST_EXT	Cross Street: WALNUT_AV	Location: NW
ADA ID: 58E98E757CC1	Curb Cut Type: MedianRefuge2	Initial Pass/Fail: Fail	Overall Compliance: No
Severity Score: 1.25			
Codes/Mitigation Info/Possible Solution		Field Measurements/Component Compliance

Remove & Replace Entire Refuge.
