# Access Compliance Report

## Public Rights-of-Way

### (Island Curb Cuts)

Intersection ID: 5600	Main Street: N_TRYON_ST	Cross Street: J_M_KEYNES_DR	Location: NE
ADA ID: 5ABE23763669	Curb Cut Type: MedianRefuge2	Initial Pass/Fail: Pass	Overall Compliance: No
Severity Score: 0			
Codes/Mitigation Info/Possible Solution		Field Measurements/Component Compliance

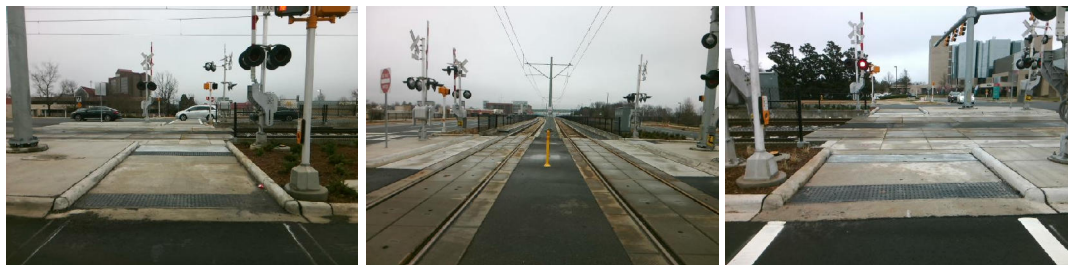
Compliance	Description	Data	Compliance	Description	Data
Yes	Refuge 1 Length (In)	48.0	Yes	Gutter 1 Ponding?	No
Yes	Refuge 1 Width (In)	120.0	Yes	Gutter 1 Lip Ht (In)	0.0
Yes	Refuge 1 Slope (%)	0.2	Yes	Gutter 1 Slope (%)	2.1
Yes	Refuge 1 X Slope (%)	0.2	Yes	Gutter 1 X Slope (%)	0.0
N/A	Painted X Walk1?	Yes	Yes	DWS 1 Provided?	Yes
N/A	X Walk 1 Direction	To NE	Yes	DWS 1 Contrast?	Yes
N/A	X Walk 1 Width (In)	99.0	No	DWS 1 Length (In)	23.5
N/A	Road 1 Slope (%)	0.3	Yes	DWS 1 Full Width?	Yes
N/A	Road 1 X Slope (%)	2.5	Yes	DWS 1 Offset (In)	1.0
Yes	Refuge 2 Length (In)	48.0	Yes	Gutter 2 Ponding?	No
Yes	Refuge 2 Width (In)	120.0	Yes	Gutter 2 Lip Ht (In)	0.0
Yes	Refuge 2 Slope (%)	0.9	Yes	Gutter 2 Slope (%)	1.3
Yes	Refuge 2 X Slope (%)	0.6	Yes	Gutter 2 X Slope (%)	0.6
N/A	Painted X Walk2?	No	Yes	DWS 2 Provided?	Yes
N/A	X Walk 2 Direction	To S	Yes	DWS 2 Contrast?	Yes
N/A	X Walk 2 Width (In)	N/A	No	DWS 2 Length (In)	23.5

N/A	Road 2 Slope (%)	1.1	Yes	DWS 2 Full Width?	Yes
N/A	Road 2 X Slope (%)	2.4	Yes	DWS 2 Offset (In)	1.0
N/A	Refuge 3 Length (in)	N/A	N/A	Gutter 3 Ponding?	N/A
N/A	Refuge 3 Width (in)	N/A	N/A	Gutter 3 Lip Ht (in)	N/A
N/A	Refuge 3 Slope (%)	N/A	N/A	Gutter 3 Slope (%)	N/A
N/A	Refuge 3 XSlope (%)	N/A	N/A	Gutter 3 XSlope (%)	N/A
N/A	Painted X Walk3?	N/A	N/A	DWS 3 Provided?	N/A
N/A	X Walk 3 Direction	N/A	N/A	DWS 3 Contrast?	N/A
N/A	X Walk 3 Width (in)	N/A	N/A	DWS 3 Length (in)	N/A
N/A	Road 3 Slope (%)	N/A	N/A	DWS 3 Full Width?	N/A
N/A	Road 3 XSlope (%)	N/A	N/A	DWS 3 Offset (in)	N/A
Yes	Any Obstructions?	No	N/A	Storm Grate/Utility Hazard?	No
N/A	Obstruction Type		N/A	Storm Grate/Utility Type	
		N/A			N/A
N/A	Surface Condition	Good

Possible Solutions:

**Remove & Replace Detectable Warning System.**
