# Access Compliance Report

## Public Rights-of-Way

### (Island Curb Cuts)

Intersection ID: 20485	Main Street: FAIRVIEW_RD	Cross Street: ASHLEY_PARK_LN	Location: SW
ADA ID: 5CB4E60871CF	Curb Cut Type: MedianRefuge2	Initial Pass/Fail: Pass	Overall Compliance: No
Severity Score: 15.25			
Codes/Mitigation Info/Possible Solution		Field Measurements/Component Compliance

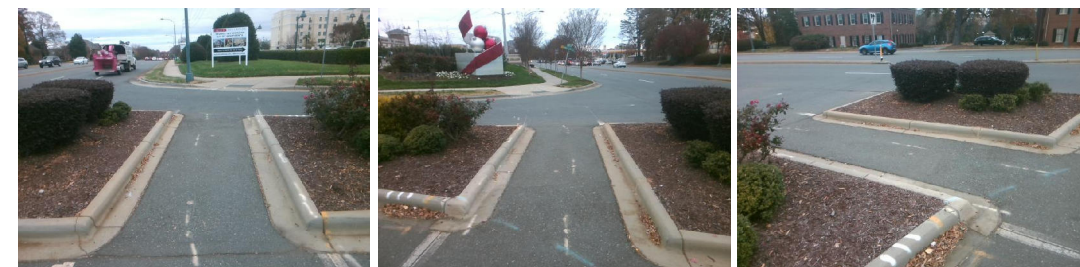
Compliance	Description	Data	Compliance	Description	Data
Yes	Refuge 1 Length (In)	100.0	Yes	Gutter 1 Ponding?	No
Yes	Refuge 1 Width (In)	85.0	Yes	Gutter 1 Lip Ht (In)	0.0
Yes	Refuge 1 Slope (%)	2.5	Yes	Gutter 1 Slope (%)	1.3
Yes	Refuge 1 X Slope (%)	0.6	Yes	Gutter 1 X Slope (%)	0.7
N/A	Painted X Walk1?	No	No	DWS 1 Provided?	No
N/A	X Walk 1 Direction	To SE	N/A	DWS 1 Contrast?	No
N/A	X Walk 1 Width (In)	N/A	N/A	DWS 1 Length (In)	N/A
N/A	Road 1 Slope (%)	0.7	N/A	DWS 1 Full Width?	No
N/A	Road 1 X Slope (%)	2.3	N/A	DWS 1 Offset (In)	N/A
Yes	Refuge 2 Length (In)	100.0	Yes	Gutter 2 Ponding?	No
Yes	Refuge 2 Width (In)	85.0	Yes	Gutter 2 Lip Ht (In)	0.0
Yes	Refuge 2 Slope (%)	1.4	Yes	Gutter 2 Slope (%)	4.3
Yes	Refuge 2 X Slope (%)	0.5	Yes	Gutter 2 X Slope (%)	1.1
N/A	Painted X Walk2?	No	No	DWS 2 Provided?	No
N/A	X Walk 2 Direction	To NW	N/A	DWS 2 Contrast?	No
N/A	X Walk 2 Width (In)	N/A	N/A	DWS 2 Length (In)	N/A
N/A	Road 2 Slope (%)	1.8	N/A	DWS 2 Full Width?	No

N/A	Road 2 X Slope (%)	1.1	N/A	DWS 2 Offset (In)	N/A
N/A	Refuge 3 Length (in)	N/A	N/A	Gutter 3 Ponding?	N/A
N/A	Refuge 3 Width (in)	N/A	N/A	Gutter 3 Lip Ht (in)	N/A
N/A	Refuge 3 Slope (%)	N/A	N/A	Gutter 3 Slope (%)	N/A
N/A	Refuge 3 XSlope (%)	N/A	N/A	Gutter 3 XSlope (%)	N/A
N/A	Painted X Walk3?	N/A	N/A	DWS 3 Provided?	N/A
N/A	X Walk 3 Direction	N/A	N/A	DWS 3 Contrast?	N/A
N/A	X Walk 3 Width (in)	N/A	N/A	DWS 3 Length (in)	N/A
N/A	Road 3 Slope (%)	N/A	N/A	DWS 3 Full Width?	N/A
N/A	Road 3 XSlope (%)	N/A	N/A	DWS 3 Offset (in)	N/A
Yes	Any Obstructions?	N/A	N/A	Storm Grate/Utility Hazard?	No
N/A	Obstruction Type		N/A	Storm Grate/Utility Type	
		N/A			N/A
N/A	Surface Condition	Good

**Install Detectable Warning System.**
