# Access Compliance Report

## Public Rights-of-Way

### (Island Curb Cuts)

Intersection ID: 43075	Main Street: SCOTT_AV	Cross Street: ROMANY_RD	Location:	N
ADA ID: 5CF62F3C2CD9	Curb Cut Type: MedianRefuge2	Initial Pass/Fail: Fail	Overall Compliance: No	Severity Score: 1.25
Codes/Mitigation Info/Possible Solution		Field Measurements/Component Compliance

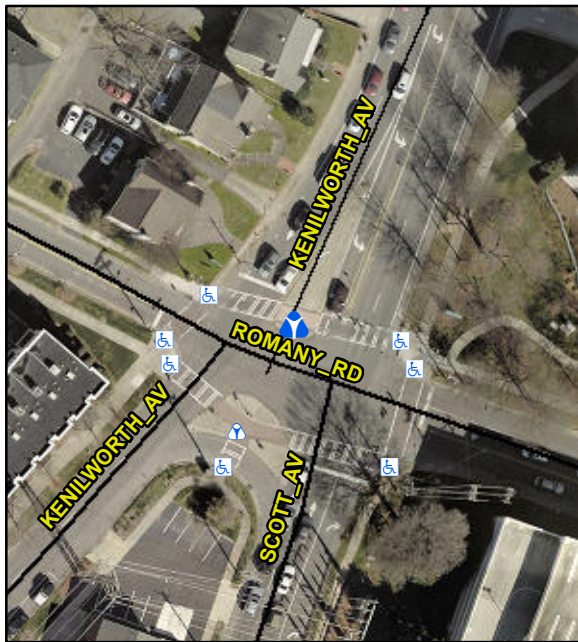
Compliance	Description	Data	Compliance	Description	Data
Yes	Refuge 1 Length (In)	122.0	N/A	Gutter 1 Ponding?	N/A
Yes	Refuge 1 Width (In)	121.0	N/A	Gutter 1 Lip Ht (In)	N/A
Yes	Refuge 1 Slope (%)	2.3	N/A	Gutter 1 Slope (%)	N/A
Yes	Refuge 1 X Slope (%)	3.2	N/A	Gutter 1 X Slope (%)	N/A
N/A	Painted X Walk1?	Yes	N/A	DWS 1 Provided?	N/A
N/A	X Walk 1 Direction	To E	N/A	DWS 1 Contrast?	N/A
N/A	X Walk 1 Width (In)	116.0	N/A	DWS 1 Length (In)	N/A
N/A	Road 1 Slope (%)	0.1	N/A	DWS 1 Full Width?	N/A
N/A	Road 1 X Slope (%)	1.6	N/A	DWS 1 Offset (In)	N/A
Yes	Refuge 2 Length (In)	122.0	N/A	Gutter 2 Ponding?	N/A
Yes	Refuge 2 Width (In)	121.0	N/A	Gutter 2 Lip Ht (In)	N/A
Yes	Refuge 2 Slope (%)	0.4	N/A	Gutter 2 Slope (%)	N/A
Yes	Refuge 2 X Slope (%)	2.7	N/A	Gutter 2 X Slope (%)	N/A
N/A	Painted X Walk2?	Yes	N/A	DWS 2 Provided?	N/A
N/A	X Walk 2 Direction	To W	N/A	DWS 2 Contrast?	N/A
N/A	X Walk 2 Width (In)	118.0	N/A	DWS 2 Length (In)	N/A

N/A	Road 2 Slope (%)	1.1	N/A	DWS 2 Full Width?	N/A
N/A	Road 2 X Slope (%)	1.9	N/A	DWS 2 Offset (In)	N/A
N/A	Refuge 3 Length (in)	N/A	N/A	Gutter 3 Ponding?	N/A
N/A	Refuge 3 Width (in)	N/A	N/A	Gutter 3 Lip Ht (in)	N/A
N/A	Refuge 3 Slope (%)	N/A	N/A	Gutter 3 Slope (%)	N/A
N/A	Refuge 3 XSlope (%)	N/A	N/A	Gutter 3 XSlope (%)	N/A
N/A	Painted X Walk3?	N/A	N/A	DWS 3 Provided?	N/A
N/A	X Walk 3 Direction	N/A	N/A	DWS 3 Contrast?	N/A
N/A	X Walk 3 Width (in)	N/A	N/A	DWS 3 Length (in)	N/A
N/A	Road 3 Slope (%)	N/A	N/A	DWS 3 Full Width?	N/A
N/A	Road 3 XSlope (%)	N/A	N/A	DWS 3 Offset (in)	N/A
Yes	Any Obstructions?	N/A	N/A	Storm Grate/Utility Hazard?	N/A
N/A	Obstruction Type		N/A	Storm Grate/Utility Type	
		N/A			N/A
N/A	Surface Condition	Good

**Remove & Replace Entire Refuge.**

Total Cost: \$ 3000.00
