# Access Compliance Report

## Public Rights-of-Way

### (Island Curb Cuts)

Intersection ID: 5714	Main Street: JOHN_KIRK_DR	Cross Street: UNIVERSITY_CITY_BV	Location: S
ADA ID: 5F4CFC30A64A	Curb Cut Type: MedianRefuge2	Initial Pass/Fail: Fail	Overall Compliance: No
Severity Score: 25			
Codes/Mitigation Info/Possible Solution		Field Measurements/Component Compliance

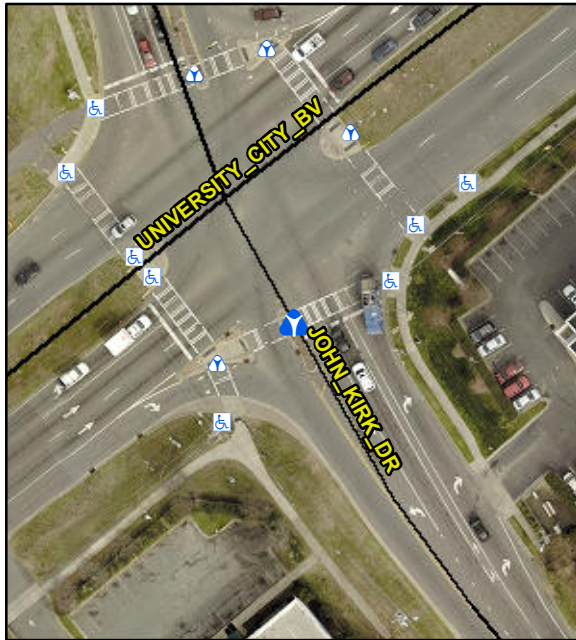
Compliance	Description	Data	Compliance	Description	Data
Yes	Refuge 1 Length (In)	37.5	N/A	Gutter 1 Ponding?	N/A
Yes	Refuge 1 Width (In)	90.0	N/A	Gutter 1 Lip Ht (In)	N/A
No	Refuge 1 Slope (%)	7.0	N/A	Gutter 1 Slope (%)	N/A
Yes	Refuge 1 X Slope (%)	0.6	N/A	Gutter 1 X Slope (%)	N/A
N/A	Painted X Walk1?	Yes	N/A	DWS 1 Provided?	N/A
N/A	X Walk 1 Direction	To NE	N/A	DWS 1 Contrast?	N/A
N/A	X Walk 1 Width (In)	110.0	N/A	DWS 1 Length (In)	N/A
N/A	Road 1 Slope (%)	0.4	N/A	DWS 1 Full Width?	N/A
N/A	Road 1 X Slope (%)	2.5	N/A	DWS 1 Offset (In)	N/A
Yes	Refuge 2 Length (In)	37.5	N/A	Gutter 2 Ponding?	N/A
Yes	Refuge 2 Width (In)	90.0	N/A	Gutter 2 Lip Ht (In)	N/A
No	Refuge 2 Slope (%)	5.2	N/A	Gutter 2 Slope (%)	N/A
Yes	Refuge 2 X Slope (%)	0.1	N/A	Gutter 2 X Slope (%)	N/A
N/A	Painted X Walk2?	Yes	N/A	DWS 2 Provided?	N/A
N/A	X Walk 2 Direction	To SW	N/A	DWS 2 Contrast?	N/A
N/A	X Walk 2 Width (In)	111.0	N/A	DWS 2 Length (In)	N/A

**Remove & Replace Entire Refuge.**
