Access Compliance Report

Public Rights-of-Way

(Island Curb Cuts)

Intersection ID: 17190	Main Street: MURRAYHILL_RD	Cross Street: SCALEYBARK_RD	Location: NW
ADA ID: 629DC4E2CD52	Curb Cut Type: MedianRefuge2	Initial Pass/Fail: Pass	Overall Compliance: No
Severity Score: 7.75			
Codes/Mitigation Info/Possible Solution		Field Measurements/Component Compliance

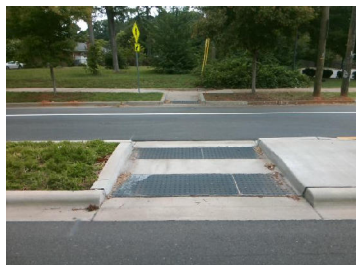
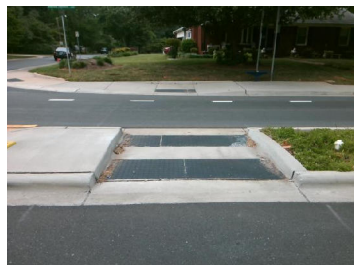
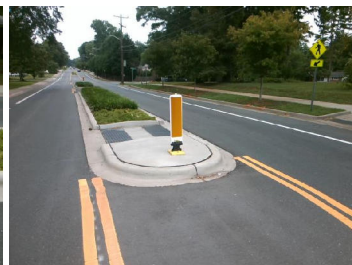
Compliance	Description	Data	Compliance	Description	Data
No	Refuge 1 Length (In)	35.5	Yes	Gutter 1 Ponding?	No
Yes	Refuge 1 Width (In)	87.0	No	Gutter 1 Lip Ht (In)	0.5
Yes	Refuge 1 Slope (%)	1.8	Yes	Gutter 1 Slope (%)	3.8
Yes	Refuge 1 X Slope (%)	0.6	No	Gutter 1 X Slope (%)	2.2
N/A	Painted X Walk1?	No	No	DWS 1 Provided?	Yes
N/A	X Walk 1 Direction	To NE	N/A	DWS 1 Contrast?	Yes
N/A	X Walk 1 Width (In)	N/A	N/A	DWS 1 Length (In)	24.0
N/A	Road 1 Slope (%)	0.1	N/A	DWS 1 Full Width?	Yes
N/A	Road 1 X Slope (%)	2.1	N/A	DWS 1 Offset (In)	1.0
No	Refuge 2 Length (In)	35.5	Yes	Gutter 2 Ponding?	No
Yes	Refuge 2 Width (In)	87.0	No	Gutter 2 Lip Ht (In)	0.5
Yes	Refuge 2 Slope (%)	2.7	Yes	Gutter 2 Slope (%)	1.2
Yes	Refuge 2 X Slope (%)	0.0	Yes	Gutter 2 X Slope (%)	0.2
N/A	Painted X Walk2?	No	N/A	DWS 2 Provided?	N/A
N/A	X Walk 2 Direction	To SW	N/A	DWS 2 Contrast?	N/A
N/A	X Walk 2 Width (In)	N/A	N/A	DWS 2 Length (In)	24.0
N/A	Road 2 Slope (%)	0.0	N/A	DWS 2 Full Width?	Yes

N/A	Road 2 X Slope (%)	2.4	N/A	DWS 2 Offset (In)	1.0
N/A	Refuge 3 Length (in)	N/A	N/A	Gutter 3 Ponding?	N/A
N/A	Refuge 3 Width (in)	N/A	N/A	Gutter 3 Lip Ht (in)	N/A
N/A	Refuge 3 Slope (%)	N/A	N/A	Gutter 3 Slope (%)	N/A
N/A	Refuge 3 XSlope (%)	N/A	N/A	Gutter 3 XSlope (%)	N/A
N/A	Painted X Walk3?	N/A	N/A	DWS 3 Provided?	N/A
N/A	X Walk 3 Direction	N/A	N/A	DWS 3 Contrast?	N/A
N/A	X Walk 3 Width (in)	N/A	N/A	DWS 3 Length (in)	N/A
N/A	Road 3 Slope (%)	N/A	N/A	DWS 3 Full Width?	N/A
N/A	Road 3 XSlope (%)	N/A	N/A	DWS 3 Offset (in)	N/A
Yes	Any Obstructions?	N/A	N/A	Storm Grate/Utility Hazard?	No
N/A	Obstruction Type		N/A	Storm Grate/Utility Type	
		N/A			N/A
N/A	Surface Condition	Good

**Remove & Replace Entire Refuge.
Grind Gutter Lip. Remove & Replace
Gutter.**
