Access Compliance Report

Public Rights-of-Way

(Island Curb Cuts)

Intersection ID: 54265	Main Street: JOHNSTON_OEHLE_R_D	Cross Street: N/A	Location: E
ADA ID: 62ABDBB5DC57	Curb Cut Type: MedianRefuge2	Initial Pass/Fail: Fail	Overall Compliance: No
Codes/Mitigation Info/Possible Solution		Field Measurements/Component Compliance	
		Severity Score: 0

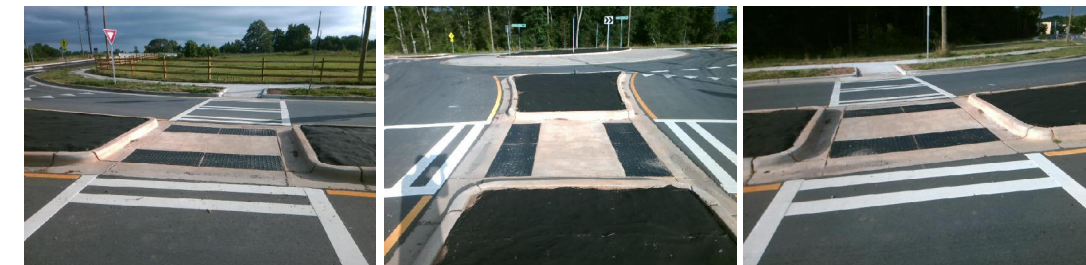
Compliance	Description	Data	Compliance	Description	Data
Yes	Refuge 1 Length (In)	48.0	N/A	Gutter 1 Ponding?	N/A
Yes	Refuge 1 Width (In)	117.0	N/A	Gutter 1 Lip Ht (In)	N/A
Yes	Refuge 1 Slope (%)	0.8	N/A	Gutter 1 Slope (%)	N/A
Yes	Refuge 1 X Slope (%)	1.6	N/A	Gutter 1 X Slope (%)	N/A
N/A	Painted X Walk1?	Yes	N/A	DWS 1 Provided?	N/A
N/A	X Walk 1 Direction	To S	N/A	DWS 1 Contrast?	N/A
N/A	X Walk 1 Width (In)	104.0	N/A	DWS 1 Length (In)	N/A
N/A	Road 1 Slope (%)	0.5	N/A	DWS 1 Full Width?	N/A
N/A	Road 1 X Slope (%)	1.8	N/A	DWS 1 Offset (In)	N/A
Yes	Refuge 2 Length (In)	48.0	N/A	Gutter 2 Ponding?	N/A
Yes	Refuge 2 Width (In)	117.0	N/A	Gutter 2 Lip Ht (In)	N/A
Yes	Refuge 2 Slope (%)	1.3	N/A	Gutter 2 Slope (%)	N/A
Yes	Refuge 2 X Slope (%)	2.5	N/A	Gutter 2 X Slope (%)	N/A
N/A	Painted X Walk2?	Yes	N/A	DWS 2 Provided?	N/A
N/A	X Walk 2 Direction	To N	N/A	DWS 2 Contrast?	N/A
N/A	X Walk 2 Width (In)	104.0	N/A	DWS 2 Length (In)	N/A

N/A	Road 2 Slope (%)	1.5	N/A	DWS 2 Full Width?	N/A
N/A	Road 2 X Slope (%)	1.2	N/A	DWS 2 Offset (In)	N/A
N/A	Refuge 3 Length (in)	N/A	N/A	Gutter 3 Ponding?	N/A
N/A	Refuge 3 Width (in)	N/A	N/A	Gutter 3 Lip Ht (in)	N/A
N/A	Refuge 3 Slope (%)	N/A	N/A	Gutter 3 Slope (%)	N/A
N/A	Refuge 3 XSlope (%)	N/A	N/A	Gutter 3 XSlope (%)	N/A
N/A	Painted X Walk3?	No	N/A	DWS 3 Provided?	N/A
N/A	X Walk 3 Direction	N/A	N/A	DWS 3 Contrast?	N/A
N/A	X Walk 3 Width (in)	N/A	N/A	DWS 3 Length (in)	N/A
N/A	Road 3 Slope (%)	N/A	N/A	DWS 3 Full Width?	N/A
N/A	Road 3 XSlope (%)	N/A	N/A	DWS 3 Offset (in)	N/A
Yes	Any Obstructions?	N/A	N/A	Storm Grate/Utility Hazard?	N/A
N/A	Obstruction Type		N/A	Storm Grate/Utility Type	
		N/A			N/A
N/A	Surface Condition	Good

Possible Solutions:

Remove & Replace Entire Refuge.
