Access Compliance Report

Public Rights-of-Way

(Island Curb Cuts)

Intersection ID: 19817	Main Street: MONROE_RD	Cross Street: TIMBER_SPRINGS_DR	Location: NE
ADA ID: 64DD3FA47134	Curb Cut Type: MedianRefuge2	Initial Pass/Fail: Fail	Overall Compliance: No
Codes/Mitigation Info/Possible Solution		Field Measurements/Component Compliance

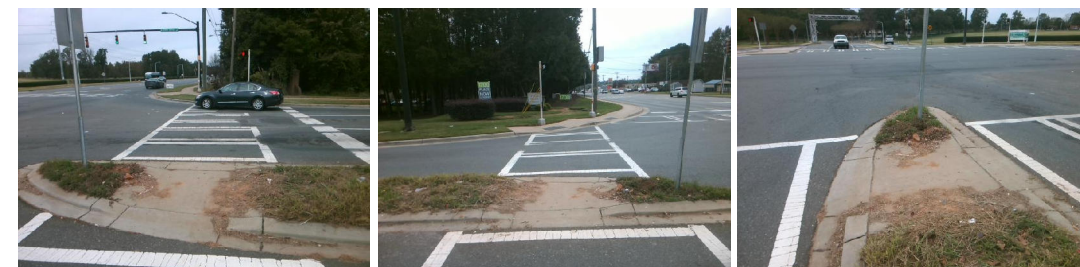
Compliance	Description	Data	Compliance	Description	Data
No	Refuge 1 Length (In)	27.5	N/A	Gutter 1 Ponding?	N/A
Yes	Refuge 1 Width (In)	84.0	N/A	Gutter 1 Lip Ht (In)	N/A
No	Refuge 1 Slope (%)	6.6	N/A	Gutter 1 Slope (%)	N/A
Yes	Refuge 1 X Slope (%)	2.3	N/A	Gutter 1 X Slope (%)	N/A
N/A	Painted X Walk1?	Yes	N/A	DWS 1 Provided?	N/A
N/A	X Walk 1 Direction	To NW	N/A	DWS 1 Contrast?	N/A
N/A	X Walk 1 Width (In)	112.0	N/A	DWS 1 Length (In)	N/A
N/A	Road 1 Slope (%)	0.2	N/A	DWS 1 Full Width?	N/A
N/A	Road 1 X Slope (%)	1.4	N/A	DWS 1 Offset (In)	N/A
No	Refuge 2 Length (In)	27.5	N/A	Gutter 2 Ponding?	N/A
Yes	Refuge 2 Width (In)	84.0	N/A	Gutter 2 Lip Ht (In)	N/A
Yes	Refuge 2 Slope (%)	4.8	N/A	Gutter 2 Slope (%)	N/A
Yes	Refuge 2 X Slope (%)	3.1	N/A	Gutter 2 X Slope (%)	N/A
N/A	Painted X Walk2?	Yes	N/A	DWS 2 Provided?	N/A
N/A	X Walk 2 Direction	To SE	N/A	DWS 2 Contrast?	N/A
N/A	X Walk 2 Width (In)	114.0	N/A	DWS 2 Length (In)	N/A

N/A	Road 2 Slope (%)	1.1	N/A	DWS 2 Full Width?	N/A
N/A	Road 2 X Slope (%)	3.7	N/A	DWS 2 Offset (In)	N/A
N/A	Refuge 3 Length (in)	N/A	N/A	Gutter 3 Ponding?	N/A
N/A	Refuge 3 Width (in)	N/A	N/A	Gutter 3 Lip Ht (in)	N/A
N/A	Refuge 3 Slope (%)	N/A	N/A	Gutter 3 Slope (%)	N/A
N/A	Refuge 3 XSlope (%)	N/A	N/A	Gutter 3 XSlope (%)	N/A
N/A	Painted X Walk3?	N/A	N/A	DWS 3 Provided?	N/A
N/A	X Walk 3 Direction	N/A	N/A	DWS 3 Contrast?	N/A
N/A	X Walk 3 Width (in)	N/A	N/A	DWS 3 Length (in)	N/A
N/A	Road 3 Slope (%)	N/A	N/A	DWS 3 Full Width?	N/A
N/A	Road 3 XSlope (%)	N/A	N/A	DWS 3 Offset (in)	N/A
Yes	Any Obstructions?	N/A	N/A	Storm Grate/Utility Hazard?	N/A
N/A	Obstruction Type		N/A	Storm Grate/Utility Type	
		N/A			N/A
N/A	Surface Condition	Good

Possible Solutions:

Remove & Replace Entire Refuge.
