# Access Compliance Report

## Public Rights-of-Way

### (Island Curb Cuts)

Intersection ID: 53488	Main Street: WAVERLY_WALK_AV	Cross Street: MATTHEWS FARM LN	Location: N
ADA ID: 6923F6E82A5C	Curb Cut Type: MedianRefuge2	Initial Pass/Fail: Fail	Overall Compliance: No
Codes/Mitigation Info/Possible Solution		Field Measurements/Component Compliance

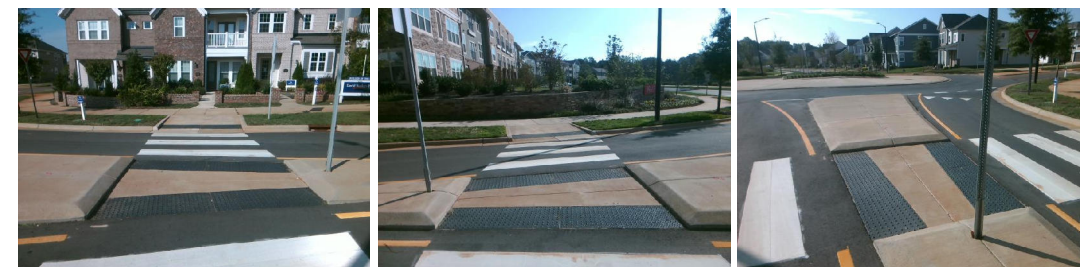
Compliance	Description	Data	Compliance	Description	Data
Yes	Refuge 1 Length (In)	37.0	N/A	Gutter 1 Ponding?	N/A
Yes	Refuge 1 Width (In)	120.0	N/A	Gutter 1 Lip Ht (In)	N/A
Yes	Refuge 1 Slope (%)	0.5	N/A	Gutter 1 Slope (%)	N/A
Yes	Refuge 1 X Slope (%)	3.8	N/A	Gutter 1 X Slope (%)	N/A
N/A	Painted X Walk1?	Yes	N/A	DWS 1 Provided?	N/A
N/A	X Walk 1 Direction	To W	N/A	DWS 1 Contrast?	N/A
N/A	X Walk 1 Width (In)	121.0	N/A	DWS 1 Length (In)	N/A
N/A	Road 1 Slope (%)	2.6	N/A	DWS 1 Full Width?	N/A
N/A	Road 1 X Slope (%)	4.3	N/A	DWS 1 Offset (In)	N/A
Yes	Refuge 2 Length (In)	37.0	N/A	Gutter 2 Ponding?	N/A
Yes	Refuge 2 Width (In)	120.0	N/A	Gutter 2 Lip Ht (In)	N/A
Yes	Refuge 2 Slope (%)	0.4	N/A	Gutter 2 Slope (%)	N/A
Yes	Refuge 2 X Slope (%)	3.4	N/A	Gutter 2 X Slope (%)	N/A
N/A	Painted X Walk2?	Yes	N/A	DWS 2 Provided?	N/A
N/A	X Walk 2 Direction	To E	N/A	DWS 2 Contrast?	N/A
N/A	X Walk 2 Width (In)	122.0	N/A	DWS 2 Length (In)	N/A

N/A	Road 2 Slope (%)	1.9	N/A	DWS 2 Full Width?	N/A
N/A	Road 2 X Slope (%)	3.4	N/A	DWS 2 Offset (In)	N/A
N/A	Refuge 3 Length (in)	N/A	N/A	Gutter 3 Ponding?	N/A
N/A	Refuge 3 Width (in)	N/A	N/A	Gutter 3 Lip Ht (in)	N/A
N/A	Refuge 3 Slope (%)	N/A	N/A	Gutter 3 Slope (%)	N/A
N/A	Refuge 3 XSlope (%)	N/A	N/A	Gutter 3 XSlope (%)	N/A
N/A	Painted X Walk3?	N/A	N/A	DWS 3 Provided?	N/A
N/A	X Walk 3 Direction	N/A	N/A	DWS 3 Contrast?	N/A
N/A	X Walk 3 Width (in)	N/A	N/A	DWS 3 Length (in)	N/A
N/A	Road 3 Slope (%)	N/A	N/A	DWS 3 Full Width?	N/A
N/A	Road 3 XSlope (%)	N/A	N/A	DWS 3 Offset (in)	N/A
Yes	Any Obstructions?	N/A	N/A	Storm Grate/Utility Hazard?	N/A
N/A	Obstruction Type		N/A	Storm Grate/Utility Type	
		N/A			N/A
N/A	Surface Condition	Good

Possible Solutions:

**Remove & Replace Entire Refuge.**
