Access Compliance Report

Public Rights-of-Way

(Island Curb Cuts)

Intersection ID: 11318	Main Street: GRANDIN_RD	Cross Street: W_4TH_ST_EXT	Location: NW
ADA ID: 6B361C65FBBF	Curb Cut Type: MedianRefuge2	Initial Pass/Fail: Pass	Overall Compliance: No
Severity Score: 0.25			
Codes/Mitigation Info/Possible Solution		Field Measurements/Component Compliance

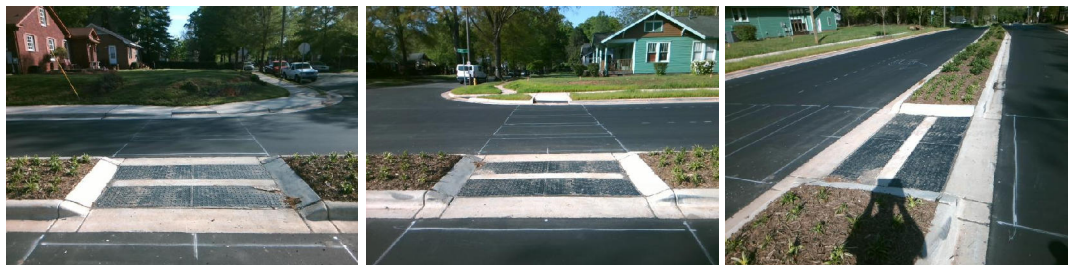
Compliance	Description	Data	Compliance	Description	Data
No	Refuge 1 Length (In)	28.0	Yes	Gutter 1 Ponding?	No
Yes	Refuge 1 Width (In)	100.0	Yes	Gutter 1 Lip Ht (In)	0.0
Yes	Refuge 1 Slope (%)	1.8	Yes	Gutter 1 Slope (%)	3.0
Yes	Refuge 1 X Slope (%)	1.1	Yes	Gutter 1 X Slope (%)	0.2
N/A	Painted X Walk1?	No	No	DWS 1 Provided?	Yes
N/A	X Walk 1 Direction	To NE	N/A	DWS 1 Contrast?	Yes
N/A	X Walk 1 Width (In)	N/A	N/A	DWS 1 Length (In)	24.0
N/A	Road 1 Slope (%)	0.7	N/A	DWS 1 Full Width?	Yes
N/A	Road 1 X Slope (%)	1.8	N/A	DWS 1 Offset (In)	0.0
No	Refuge 2 Length (In)	28.0	Yes	Gutter 2 Ponding?	No
Yes	Refuge 2 Width (In)	100.0	Yes	Gutter 2 Lip Ht (In)	0.0
Yes	Refuge 2 Slope (%)	2.3	Yes	Gutter 2 Slope (%)	2.6
Yes	Refuge 2 X Slope (%)	0.8	No	Gutter 2 X Slope (%)	2.1
N/A	Painted X Walk2?	No	No	DWS 2 Provided?	Yes
N/A	X Walk 2 Direction	To SW	N/A	DWS 2 Contrast?	Yes
N/A	X Walk 2 Width (In)	N/A	N/A	DWS 2 Length (In)	24.0

N/A	Road 2 Slope (%)	1.0	N/A	DWS 2 Full Width?	Yes
N/A	Road 2 X Slope (%)	0.2	N/A	DWS 2 Offset (In)	0.0
N/A	Refuge 3 Length (in)	N/A	N/A	Gutter 3 Ponding?	N/A
N/A	Refuge 3 Width (in)	N/A	N/A	Gutter 3 Lip Ht (in)	N/A
N/A	Refuge 3 Slope (%)	N/A	N/A	Gutter 3 Slope (%)	N/A
N/A	Refuge 3 XSlope (%)	N/A	N/A	Gutter 3 XSlope (%)	N/A
N/A	Painted X Walk3?	N/A	N/A	DWS 3 Provided?	N/A
N/A	X Walk 3 Direction	N/A	N/A	DWS 3 Contrast?	N/A
N/A	X Walk 3 Width (in)	N/A	N/A	DWS 3 Length (in)	N/A
N/A	Road 3 Slope (%)	N/A	N/A	DWS 3 Full Width?	N/A
N/A	Road 3 XSlope (%)	N/A	N/A	DWS 3 Offset (in)	N/A
Yes	Any Obstructions?	No	N/A	Storm Grate/Utility Hazard?	No
N/A	Obstruction Type		N/A	Storm Grate/Utility Type	
		N/A			N/A
N/A	Surface Condition	Good

Remove & Replace Entire Refuge.
Remove & Replace Gutter.
