Access Compliance Report

Public Rights-of-Way

(Island Curb Cuts)

Intersection ID: 48160	Main Street: NORTHLAKE CENTRE PY	Cross Street: N/A	Location: SW
ADA ID: 6B961CE908D7	Curb Cut Type: MedianRefuge2	Initial Pass/Fail: Fail	Overall Compliance: No
Severity Score: 1.25			
Codes/Mitigation Info/Possible Solution		Field Measurements/Component Compliance

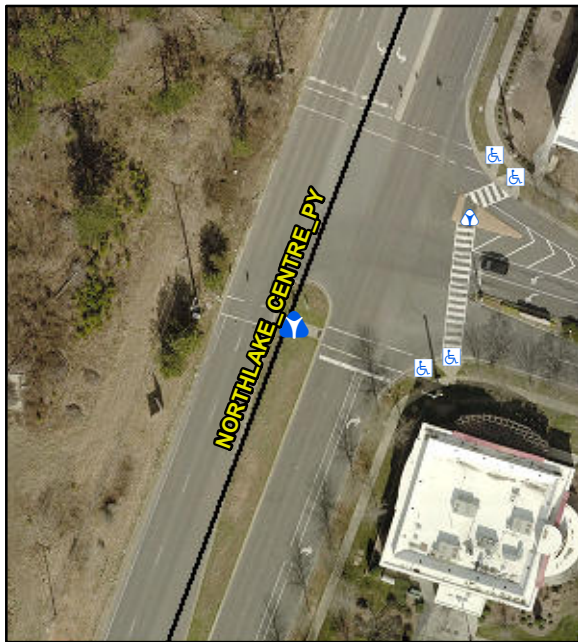
Compliance	Description	Data	Compliance	Description	Data
Yes	Refuge 1 Length (In)	150.0	N/A	Gutter 1 Ponding?	N/A
Yes	Refuge 1 Width (In)	73.0	N/A	Gutter 1 Lip Ht (In)	N/A
Yes	Refuge 1 Slope (%)	3.3	N/A	Gutter 1 Slope (%)	N/A
Yes	Refuge 1 X Slope (%)	2.0	N/A	Gutter 1 X Slope (%)	N/A
N/A	Painted X Walk1?	Yes	N/A	DWS 1 Provided?	N/A
N/A	X Walk 1 Direction	To NW	N/A	DWS 1 Contrast?	N/A
N/A	X Walk 1 Width (In)	108.0	N/A	DWS 1 Length (In)	N/A
N/A	Road 1 Slope (%)	2.3	N/A	DWS 1 Full Width?	N/A
N/A	Road 1 X Slope (%)	1.0	N/A	DWS 1 Offset (In)	N/A
Yes	Refuge 2 Length (In)	150.0	N/A	Gutter 2 Ponding?	N/A
Yes	Refuge 2 Width (In)	73.0	N/A	Gutter 2 Lip Ht (In)	N/A
Yes	Refuge 2 Slope (%)	4.5	N/A	Gutter 2 Slope (%)	N/A
Yes	Refuge 2 X Slope (%)	3.2	N/A	Gutter 2 X Slope (%)	N/A
N/A	Painted X Walk2?	Yes	N/A	DWS 2 Provided?	N/A
N/A	X Walk 2 Direction	To SE	N/A	DWS 2 Contrast?	N/A
N/A	X Walk 2 Width (In)	108.0	N/A	DWS 2 Length (In)	N/A

N/A	Road 2 Slope (%)	3.0	N/A	DWS 2 Full Width?	N/A
N/A	Road 2 X Slope (%)	3.9	N/A	DWS 2 Offset (In)	N/A
N/A	Refuge 3 Length (in)	N/A	N/A	Gutter 3 Ponding?	N/A
N/A	Refuge 3 Width (in)	N/A	N/A	Gutter 3 Lip Ht (in)	N/A
N/A	Refuge 3 Slope (%)	N/A	N/A	Gutter 3 Slope (%)	N/A
N/A	Refuge 3 XSlope (%)	N/A	N/A	Gutter 3 XSlope (%)	N/A
N/A	Painted X Walk3?	N/A	N/A	DWS 3 Provided?	N/A
N/A	X Walk 3 Direction	N/A	N/A	DWS 3 Contrast?	N/A
N/A	X Walk 3 Width (in)	N/A	N/A	DWS 3 Length (in)	N/A
N/A	Road 3 Slope (%)	N/A	N/A	DWS 3 Full Width?	N/A
N/A	Road 3 XSlope (%)	N/A	N/A	DWS 3 Offset (in)	N/A
Yes	Any Obstructions?	N/A	N/A	Storm Grate/Utility Hazard?	N/A
N/A	Obstruction Type		N/A	Storm Grate/Utility Type	
		N/A			N/A
N/A	Surface Condition	Good

Remove & Replace Entire Refuge.
