Access Compliance Report

Public Rights-of-Way

(Island Curb Cuts)

Intersection ID: 17169	Main Street: IDLEWILD_RD	Cross Street: CEDARS_EAST_CT	Location: SE
ADA ID: 6BAA4479AE0F	Curb Cut Type: MedianRefuge2	Initial Pass/Fail: Fail	Overall Compliance: No
Codes/Mitigation Info/Possible Solution		Field Measurements/Component Compliance	
Severity Score: 0

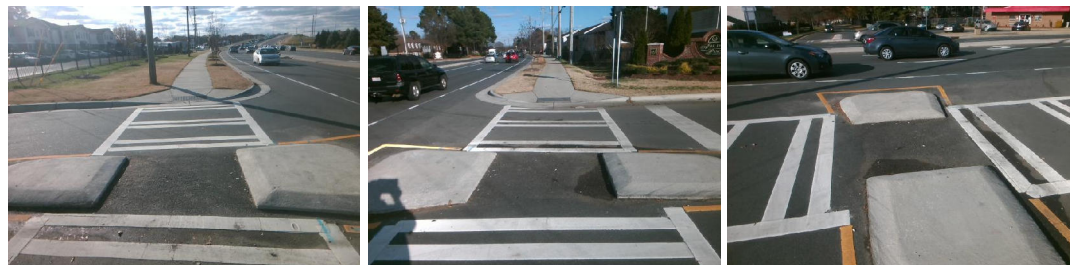
Compliance	Description	Data	Compliance	Description	Data
No	Refuge 1 Length (In)	30.0	N/A	Gutter 1 Ponding?	N/A
Yes	Refuge 1 Width (In)	72.0	N/A	Gutter 1 Lip Ht (In)	N/A
Yes	Refuge 1 Slope (%)	1.2	N/A	Gutter 1 Slope (%)	N/A
Yes	Refuge 1 X Slope (%)	3.0	N/A	Gutter 1 X Slope (%)	N/A
N/A	Painted X Walk1?	Yes	N/A	DWS 1 Provided?	N/A
N/A	X Walk 1 Direction	To SW	N/A	DWS 1 Contrast?	N/A
N/A	X Walk 1 Width (In)	112.0	N/A	DWS 1 Length (In)	N/A
N/A	Road 1 Slope (%)	1.8	N/A	DWS 1 Full Width?	N/A
N/A	Road 1 X Slope (%)	0.7	N/A	DWS 1 Offset (In)	N/A
No	Refuge 2 Length (In)	30.0	N/A	Gutter 2 Ponding?	N/A
Yes	Refuge 2 Width (In)	72.0	N/A	Gutter 2 Lip Ht (In)	N/A
Yes	Refuge 2 Slope (%)	0.1	N/A	Gutter 2 Slope (%)	N/A
Yes	Refuge 2 X Slope (%)	4.0	N/A	Gutter 2 X Slope (%)	N/A
N/A	Painted X Walk2?	Yes	N/A	DWS 2 Provided?	N/A
N/A	X Walk 2 Direction	To NE	N/A	DWS 2 Contrast?	N/A
N/A	X Walk 2 Width (In)	111.0	N/A	DWS 2 Length (In)	N/A

N/A	Road 2 Slope (%)	0.1	N/A	DWS 2 Full Width?	N/A
N/A	Road 2 X Slope (%)	0.5	N/A	DWS 2 Offset (In)	N/A
N/A	Refuge 3 Length (in)	N/A	N/A	Gutter 3 Ponding?	N/A
N/A	Refuge 3 Width (in)	N/A	N/A	Gutter 3 Lip Ht (in)	N/A
N/A	Refuge 3 Slope (%)	N/A	N/A	Gutter 3 Slope (%)	N/A
N/A	Refuge 3 XSlope (%)	N/A	N/A	Gutter 3 XSlope (%)	N/A
N/A	Painted X Walk3?	N/A	N/A	DWS 3 Provided?	N/A
N/A	X Walk 3 Direction	N/A	N/A	DWS 3 Contrast?	N/A
N/A	X Walk 3 Width (in)	N/A	N/A	DWS 3 Length (in)	N/A
N/A	Road 3 Slope (%)	N/A	N/A	DWS 3 Full Width?	N/A
N/A	Road 3 XSlope (%)	N/A	N/A	DWS 3 Offset (in)	N/A
Yes	Any Obstructions?	N/A	N/A	Storm Grate/Utility Hazard?	N/A
N/A	Obstruction Type		N/A	Storm Grate/Utility Type	
		N/A			N/A
N/A	Surface Condition	Good

Remove & Replace Entire Refuge.
