Access Compliance Report

Public Rights-of-Way

(Island Curb Cuts)

Intersection ID: 44555	Main Street: UNIVERSITY_CITY_BV	Cross Street: N_TRYON_ST	Location:	W
ADA ID: 6C2F84AED502	Curb Cut Type: MedianRefuge2	Initial Pass/Fail: Pass	Overall Compliance: No	Severity Score: 12.5

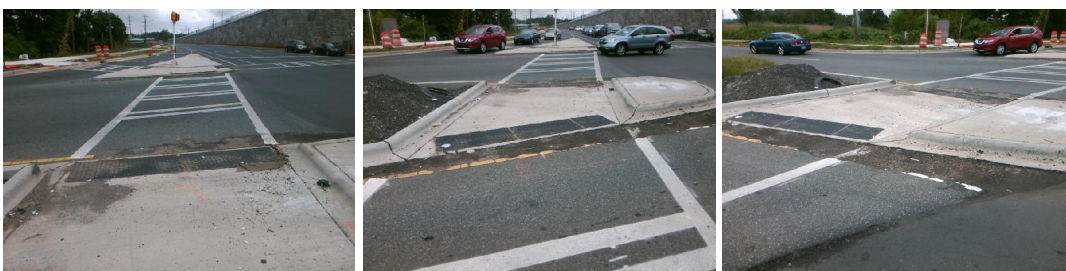
Yes	Gutter 1 Slope (%)	2.8
			No	Gutter 1 X Slope (%)	4.1
			Yes	DWS 1 Provided?	Yes
			Yes	DWS 1 Contrast?	Yes
			No	DWS 1 Length (In)	23.5
			No	DWS 1 Full Width?	No
			Yes	DWS 1 Offset (In)	0.0
			No	Gutter 2 Ponding?	Yes
<p>Total Cost:</p> <p>\$ 2550.00</p>			No	Gutter 2 Lip Ht (In)	0.25
			Yes	Gutter 2 Slope (%)	0.2
			Yes	Gutter 2 X Slope (%)	0.2
			Yes	DWS 2 Provided?	Yes
			Yes	DWS 2 Contrast?	Yes
			Yes	DWS 2 Length (In)	24.0
			No	DWS 2 Full Width?	No
			Yes	DWS 2 Offset (In)	0.0
			N/A	Gutter 3 Ponding?	No
			N/A	Gutter 3 Lip Ht (in)	N/A

N/A	Gutter 3 Slope (%)	N/A
			N/A	Gutter 3 XSlope (%)	N/A
			No	DWS 3 Provided?	N/A
			N/A	DWS 3 Contrast?	N/A
			N/A	DWS 3 Length (in)	N/A
			N/A	DWS 3 Full Width?	N/A
			N/A	DWS 3 Offset (in)	N/A
			No	Storm Grate/Utility Hazard?	No
			N/A	Storm Grate/Utility Type	N/A
			N/A	Surface Condition	Good

Possible Solutions:		Compliance	Description	Data
	Remove & Replace Detectable Warning System. Grind Gutter Lip. Remove & Replace Gutter.		Yes	Refuge 1 Length (In)	82.5
			Yes	Refuge 1 Width (In)	122.0
			Yes	Refuge 1 Slope (%)	0.3
			Yes	Refuge 1 X Slope (%)	1.3
			N/A	Painted X Walk1?	Yes
			N/A	X Walk 1 Direction	To S
			N/A	X Walk 1 Width (In)	117.0
			N/A	Road 1 Slope (%)	1.9
			N/A	Road 1 X Slope (%)	0.1
<p>Surveyor Notes:</p> <p>N/A</p>			Yes	Refuge 2 Length (In)	82.5
			Yes	Refuge 2 Width (In)	122.0
			Yes	Refuge 2 Slope (%)	1.3
			Yes	Refuge 2 X Slope (%)	1.1
			N/A	Painted X Walk2?	Yes
			N/A	X Walk 2 Direction	To N
			N/A	X Walk 2 Width (In)	130.0
			N/A	Road 2 Slope (%)	1.4
			N/A	Road 2 X Slope (%)	1.3
			N/A	Refuge 3 Length (in)	N/A
<p>PROW/ADA:</p> <p>N/A</p>			No	Gutter 1 Ponding?	Yes
			No	Gutter 1 Lip Ht (In)	0.5
