# Access Compliance Report

## Public Rights-of-Way

### (Island Curb Cuts)

Intersection ID: 13713	Main Street: UNIVERSITY POINTE BV	Cross Street: IBM DR	Location:	E
ADA ID: 6C786B876ECA	Curb Cut Type: MedianRefuge2	Initial Pass/Fail: Pass	Overall Compliance: No	Severity Score: 30
Codes/Mitigation Info/Possible Solution		Field Measurements/Component Compliance

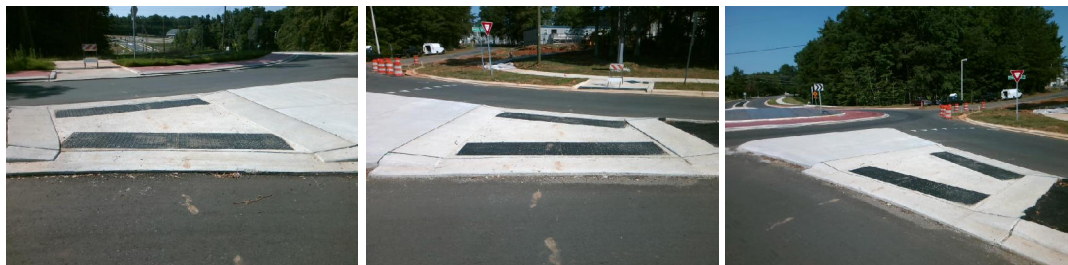
Compliance	Description	Data	Compliance	Description	Data
Yes	Refuge 1 Length (In)	45.0	Yes	Gutter 1 Ponding?	No
Yes	Refuge 1 Width (In)	122.5	No	Gutter 1 Lip Ht (In)	1.5
Yes	Refuge 1 Slope (%)	1.6	No	Gutter 1 Slope (%)	6.2
Yes	Refuge 1 X Slope (%)	0.6	Yes	Gutter 1 X Slope (%)	0.6
N/A	Painted X Walk1?	No	Yes	DWS 1 Provided?	Yes
N/A	X Walk 1 Direction	To N	Yes	DWS 1 Contrast?	Yes
N/A	X Walk 1 Width (In)	N/A	Yes	DWS 1 Length (In)	24.0
N/A	Road 1 Slope (%)	1.1	Yes	DWS 1 Full Width?	Yes
N/A	Road 1 X Slope (%)	3.7	No	DWS 1 Offset (In)	4.0
Yes	Refuge 2 Length (In)	45.0	No	Gutter 2 Ponding?	Yes
Yes	Refuge 2 Width (In)	122.5	No	Gutter 2 Lip Ht (In)	1.75
Yes	Refuge 2 Slope (%)	0.5	Yes	Gutter 2 Slope (%)	1.8
Yes	Refuge 2 X Slope (%)	1.6	Yes	Gutter 2 X Slope (%)	1.0
N/A	Painted X Walk2?	No	Yes	DWS 2 Provided?	Yes
N/A	X Walk 2 Direction	To S	Yes	DWS 2 Contrast?	Yes
N/A	X Walk 2 Width (In)	N/A	Yes	DWS 2 Length (In)	24.0

N/A	Road 2 Slope (%)	1.1	No	DWS 2 Full Width?	No
N/A	Road 2 X Slope (%)	1.5	No	DWS 2 Offset (In)	4.5
N/A	Refuge 3 Length (in)	N/A	N/A	Gutter 3 Ponding?	No
N/A	Refuge 3 Width (in)	N/A	N/A	Gutter 3 Lip Ht (in)	N/A
N/A	Refuge 3 Slope (%)	N/A	N/A	Gutter 3 Slope (%)	N/A
N/A	Refuge 3 XSlope (%)	N/A	N/A	Gutter 3 XSlope (%)	N/A
N/A	Painted X Walk3?	No	N/A	DWS 3 Provided?	N/A
N/A	X Walk 3 Direction	N/A	N/A	DWS 3 Contrast?	N/A
N/A	X Walk 3 Width (in)	N/A	N/A	DWS 3 Length (in)	N/A
N/A	Road 3 Slope (%)	N/A	N/A	DWS 3 Full Width?	N/A
N/A	Road 3 XSlope (%)	N/A	N/A	DWS 3 Offset (in)	N/A
Yes	Any Obstructions?	No	N/A	Storm Grate/Utility Hazard?	No
N/A	Obstruction Type		N/A	Storm Grate/Utility Type	
N/A	Surface Condition	Good			N/A

**Remove & Replace Detectable Warning System. Grind Gutter Lip. Remove & Replace Gutter.**
