Access Compliance Report

Public Rights-of-Way

(Island Curb Cuts)

Intersection ID: 53421	Main Street: ARDREY_KELL_RD	Cross Street: N/A	Location: W
ADA ID: 6F5A5FF2FB32	Curb Cut Type: MedianRefuge2	Initial Pass/Fail: Fail	Overall Compliance: No
Severity Score: 1.25			
Codes/Mitigation Info/Possible Solution		Field Measurements/Component Compliance

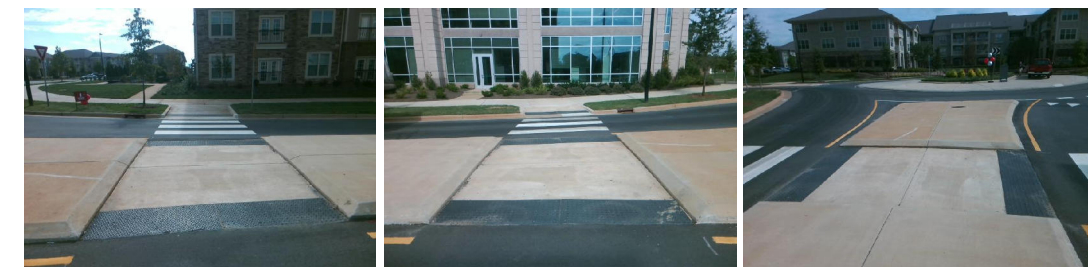
Compliance	Description	Data	Compliance	Description	Data
Yes	Refuge 1 Length (In)	83.5	N/A	Gutter 1 Ponding?	N/A
Yes	Refuge 1 Width (In)	120.0	N/A	Gutter 1 Lip Ht (In)	N/A
Yes	Refuge 1 Slope (%)	0.8	N/A	Gutter 1 Slope (%)	N/A
Yes	Refuge 1 X Slope (%)	2.9	N/A	Gutter 1 X Slope (%)	N/A
N/A	Painted X Walk1?	Yes	N/A	DWS 1 Provided?	N/A
N/A	X Walk 1 Direction	To S	N/A	DWS 1 Contrast?	N/A
N/A	X Walk 1 Width (In)	121.0	N/A	DWS 1 Length (In)	N/A
N/A	Road 1 Slope (%)	0.3	N/A	DWS 1 Full Width?	N/A
N/A	Road 1 X Slope (%)	3.2	N/A	DWS 1 Offset (In)	N/A
Yes	Refuge 2 Length (In)	83.5	N/A	Gutter 2 Ponding?	N/A
Yes	Refuge 2 Width (In)	120.0	N/A	Gutter 2 Lip Ht (In)	N/A
Yes	Refuge 2 Slope (%)	2.6	N/A	Gutter 2 Slope (%)	N/A
Yes	Refuge 2 X Slope (%)	1.0	N/A	Gutter 2 X Slope (%)	N/A
N/A	Painted X Walk2?	Yes	N/A	DWS 2 Provided?	N/A
N/A	X Walk 2 Direction	To N	N/A	DWS 2 Contrast?	N/A
N/A	X Walk 2 Width (In)	120.0	N/A	DWS 2 Length (In)	N/A

N/A	Road 2 Slope (%)	0.2	N/A	DWS 2 Full Width?	N/A
N/A	Road 2 X Slope (%)	2.3	N/A	DWS 2 Offset (In)	N/A
N/A	Refuge 3 Length (in)	N/A	N/A	Gutter 3 Ponding?	N/A
N/A	Refuge 3 Width (in)	N/A	N/A	Gutter 3 Lip Ht (in)	N/A
N/A	Refuge 3 Slope (%)	N/A	N/A	Gutter 3 Slope (%)	N/A
N/A	Refuge 3 XSlope (%)	N/A	N/A	Gutter 3 XSlope (%)	N/A
N/A	Painted X Walk3?	N/A	N/A	DWS 3 Provided?	N/A
N/A	X Walk 3 Direction	N/A	N/A	DWS 3 Contrast?	N/A
N/A	X Walk 3 Width (in)	N/A	N/A	DWS 3 Length (in)	N/A
N/A	Road 3 Slope (%)	N/A	N/A	DWS 3 Full Width?	N/A
N/A	Road 3 XSlope (%)	N/A	N/A	DWS 3 Offset (in)	N/A
Yes	Any Obstructions?	N/A	N/A	Storm Grate/Utility Hazard?	N/A
N/A	Obstruction Type		N/A	Storm Grate/Utility Type	
		N/A			N/A
N/A	Surface Condition	Good

Remove & Replace Entire Refuge.
