# Access Compliance Report

## Public Rights-of-Way

### (Island Curb Cuts)

Intersection ID: 21454	Main Street: SARDIS_RD_NORTH	Cross Street: MAPLE_SHADE_LN	Location: E
ADA ID: 7179CCC6D48B	Curb Cut Type: MedianRefuge2	Initial Pass/Fail: Fail	Overall Compliance: No
Codes/Mitigation Info/Possible Solution		Field Measurements/Component Compliance	
Severity Score: 0

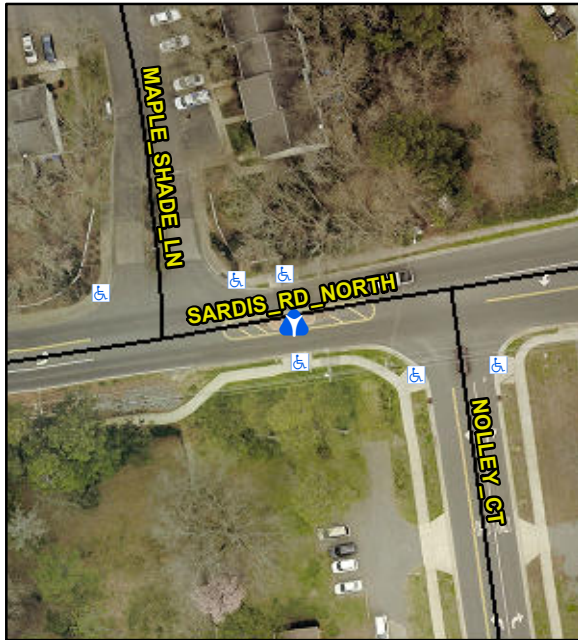
Compliance	Description	Data	Compliance	Description	Data
No	Refuge 1 Length (In)	35.5	N/A	Gutter 1 Ponding?	N/A
Yes	Refuge 1 Width (In)	98.0	N/A	Gutter 1 Lip Ht (In)	N/A
Yes	Refuge 1 Slope (%)	0.2	N/A	Gutter 1 Slope (%)	N/A
Yes	Refuge 1 X Slope (%)	0.9	N/A	Gutter 1 X Slope (%)	N/A
N/A	Painted X Walk1?	No	N/A	DWS 1 Provided?	N/A
N/A	X Walk 1 Direction	To S	N/A	DWS 1 Contrast?	N/A
N/A	X Walk 1 Width (In)	N/A	N/A	DWS 1 Length (In)	N/A
N/A	Road 1 Slope (%)	1.0	N/A	DWS 1 Full Width?	N/A
N/A	Road 1 X Slope (%)	2.6	N/A	DWS 1 Offset (In)	N/A
No	Refuge 2 Length (In)	35.5	N/A	Gutter 2 Ponding?	N/A
Yes	Refuge 2 Width (In)	98.0	N/A	Gutter 2 Lip Ht (In)	N/A
Yes	Refuge 2 Slope (%)	1.1	N/A	Gutter 2 Slope (%)	N/A
Yes	Refuge 2 X Slope (%)	2.5	N/A	Gutter 2 X Slope (%)	N/A
N/A	Painted X Walk2?	No	N/A	DWS 2 Provided?	N/A
N/A	X Walk 2 Direction	To N	N/A	DWS 2 Contrast?	N/A
N/A	X Walk 2 Width (In)	N/A	N/A	DWS 2 Length (In)	N/A

N/A	Road 2 Slope (%)	1.5	N/A	DWS 2 Full Width?	N/A
N/A	Road 2 X Slope (%)	5.3	N/A	DWS 2 Offset (In)	N/A
N/A	Refuge 3 Length (in)	N/A	N/A	Gutter 3 Ponding?	N/A
N/A	Refuge 3 Width (in)	N/A	N/A	Gutter 3 Lip Ht (in)	N/A
N/A	Refuge 3 Slope (%)	N/A	N/A	Gutter 3 Slope (%)	N/A
N/A	Refuge 3 XSlope (%)	N/A	N/A	Gutter 3 XSlope (%)	N/A
N/A	Painted X Walk3?	N/A	N/A	DWS 3 Provided?	N/A
N/A	X Walk 3 Direction	N/A	N/A	DWS 3 Contrast?	N/A
N/A	X Walk 3 Width (in)	N/A	N/A	DWS 3 Length (in)	N/A
N/A	Road 3 Slope (%)	N/A	N/A	DWS 3 Full Width?	N/A
N/A	Road 3 XSlope (%)	N/A	N/A	DWS 3 Offset (in)	N/A
Yes	Any Obstructions?	N/A	N/A	Storm Grate/Utility Hazard?	N/A
N/A	Obstruction Type		N/A	Storm Grate/Utility Type	
		N/A			N/A
N/A	Surface Condition	Good

Possible Solutions:

**Remove & Replace Entire Refuge.**

**\$ 3000.00**
