Access Compliance Report

Public Rights-of-Way

(Island Curb Cuts)

Intersection ID: 18776	Main Street: SOUTH_BV	Cross Street: TYVOLA_RD	Location: N
ADA ID: 73D67A80A152	Curb Cut Type: MedianRefuge2	Initial Pass/Fail: Fail	Overall Compliance: No
Codes/Mitigation Info/Possible Solution		Field Measurements/Component Compliance

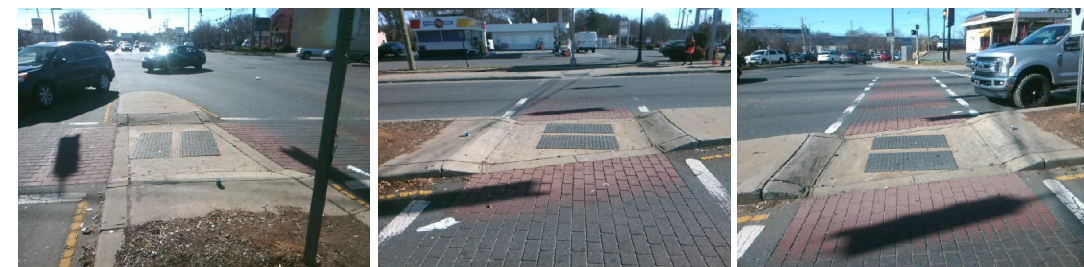
Compliance	Description	Data	Compliance	Description	Data
No	Refuge 1 Length (In)	31.0	N/A	Gutter 1 Ponding?	N/A
Yes	Refuge 1 Width (In)	91.0	N/A	Gutter 1 Lip Ht (In)	N/A
Yes	Refuge 1 Slope (%)	2.9	N/A	Gutter 1 Slope (%)	N/A
Yes	Refuge 1 X Slope (%)	3.2	N/A	Gutter 1 X Slope (%)	N/A
N/A	Painted X Walk1?	Yes	N/A	DWS 1 Provided?	N/A
N/A	X Walk 1 Direction	To E	N/A	DWS 1 Contrast?	N/A
N/A	X Walk 1 Width (In)	114.0	N/A	DWS 1 Length (In)	N/A
N/A	Road 1 Slope (%)	0.8	N/A	DWS 1 Full Width?	N/A
N/A	Road 1 X Slope (%)	2.3	N/A	DWS 1 Offset (In)	N/A
No	Refuge 2 Length (In)	31.0	N/A	Gutter 2 Ponding?	N/A
Yes	Refuge 2 Width (In)	91.0	N/A	Gutter 2 Lip Ht (In)	N/A
Yes	Refuge 2 Slope (%)	1.0	N/A	Gutter 2 Slope (%)	N/A
Yes	Refuge 2 X Slope (%)	3.5	N/A	Gutter 2 X Slope (%)	N/A
N/A	Painted X Walk2?	Yes	N/A	DWS 2 Provided?	N/A
N/A	X Walk 2 Direction	To W	N/A	DWS 2 Contrast?	N/A
N/A	X Walk 2 Width (In)	114.0	N/A	DWS 2 Length (In)	N/A

N/A	Road 2 Slope (%)	0.6	N/A	DWS 2 Full Width?	N/A
N/A	Road 2 X Slope (%)	0.7	N/A	DWS 2 Offset (In)	N/A
N/A	Refuge 3 Length (in)	N/A	N/A	Gutter 3 Ponding?	N/A
N/A	Refuge 3 Width (in)	N/A	N/A	Gutter 3 Lip Ht (in)	N/A
N/A	Refuge 3 Slope (%)	N/A	N/A	Gutter 3 Slope (%)	N/A
N/A	Refuge 3 XSlope (%)	N/A	N/A	Gutter 3 XSlope (%)	N/A
N/A	Painted X Walk3?	N/A	N/A	DWS 3 Provided?	N/A
N/A	X Walk 3 Direction	N/A	N/A	DWS 3 Contrast?	N/A
N/A	X Walk 3 Width (in)	N/A	N/A	DWS 3 Length (in)	N/A
N/A	Road 3 Slope (%)	N/A	N/A	DWS 3 Full Width?	N/A
N/A	Road 3 XSlope (%)	N/A	N/A	DWS 3 Offset (in)	N/A
Yes	Any Obstructions?	N/A	N/A	Storm Grate/Utility Hazard?	N/A
N/A	Obstruction Type		N/A	Storm Grate/Utility Type	
		N/A			N/A
N/A	Surface Condition	Good

Possible Solutions:

Remove & Replace Entire Refuge.
