# Access Compliance Report

## Public Rights-of-Way

### (Island Curb Cuts)

Intersection ID: 46810	Main Street: ARBOR_VISTA_DR	Cross Street: CLAUDE_FREEMAN_DR	Location: E
ADA ID: 741AF405E8B9	Curb Cut Type: MedianRefuge2	Initial Pass/Fail: Pass	Overall Compliance: No
		Severity Score: 15.25

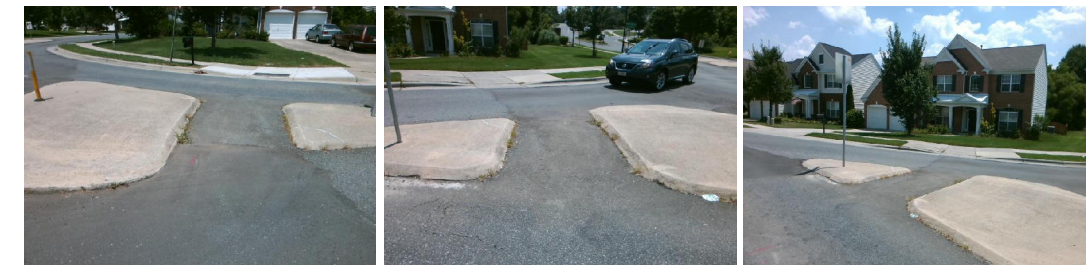
Compliance	Description	Data	Compliance	Description	Data
Yes	Refuge 1 Length (In)	42.0	Yes	Gutter 1 Ponding?	No
Yes	Refuge 1 Width (In)	60.0	No	Gutter 1 Lip Ht (In)	N/A
Yes	Refuge 1 Slope (%)	1.5	Yes	Gutter 1 Slope (%)	3.8
Yes	Refuge 1 X Slope (%)	0.3	Yes	Gutter 1 X Slope (%)	0.5
N/A	Painted X Walk1?	No	No	DWS 1 Provided?	No
N/A	X Walk 1 Direction	To S	N/A	DWS 1 Contrast?	No
N/A	X Walk 1 Width (In)	N/A	N/A	DWS 1 Length (In)	N/A
N/A	Road 1 Slope (%)	3.7	N/A	DWS 1 Full Width?	No
N/A	Road 1 X Slope (%)	5.1	N/A	DWS 1 Offset (In)	N/A
Yes	Refuge 2 Length (In)	42.0	Yes	Gutter 2 Ponding?	No
Yes	Refuge 2 Width (In)	60.0	Yes	Gutter 2 Lip Ht (In)	0.0
Yes	Refuge 2 Slope (%)	2.6	Yes	Gutter 2 Slope (%)	0.7
Yes	Refuge 2 X Slope (%)	1.9	Yes	Gutter 2 X Slope (%)	0.1
N/A	Painted X Walk2?	No	No	DWS 2 Provided?	No
N/A	X Walk 2 Direction	To N	N/A	DWS 2 Contrast?	No
N/A	X Walk 2 Width (In)	N/A	N/A	DWS 2 Length (In)	N/A
N/A	Road 2 Slope (%)	0.9	N/A	DWS 2 Full Width?	No

N/A	Road 2 X Slope (%)	1.9	N/A	DWS 2 Offset (In)	N/A
N/A	Refuge 3 Length (in)	N/A	N/A	Gutter 3 Ponding?	No
N/A	Refuge 3 Width (in)	N/A	N/A	Gutter 3 Lip Ht (in)	N/A
N/A	Refuge 3 Slope (%)	N/A	N/A	Gutter 3 Slope (%)	N/A
N/A	Refuge 3 XSlope (%)	N/A	N/A	Gutter 3 XSlope (%)	N/A
N/A	Painted X Walk3?	No	N/A	DWS 3 Provided?	N/A
N/A	X Walk 3 Direction	N/A	N/A	DWS 3 Contrast?	N/A
N/A	X Walk 3 Width (in)	N/A	N/A	DWS 3 Length (in)	N/A
N/A	Road 3 Slope (%)	N/A	N/A	DWS 3 Full Width?	N/A
N/A	Road 3 XSlope (%)	N/A	N/A	DWS 3 Offset (in)	N/A
Yes	Any Obstructions?	No	N/A	Storm Grate/Utility Hazard?	No
N/A	Obstruction Type		N/A	Storm Grate/Utility Type	
		N/A			N/A
N/A	Surface Condition	Good

**Install Detectable Warning System.  
Grind Gutter Lip.**
