Access Compliance Report

Public Rights-of-Way

(Island Curb Cuts)

Intersection ID: 14431	Main Street: N_COLONIAL_AV	Cross Street: RANDOLPH_RD	Location: S
ADA ID: 74853482DE61	Curb Cut Type: MedianRefuge2	Initial Pass/Fail: Fail	Overall Compliance: No
Severity Score: 12.5			
Codes/Mitigation Info/Possible Solution		Field Measurements/Component Compliance

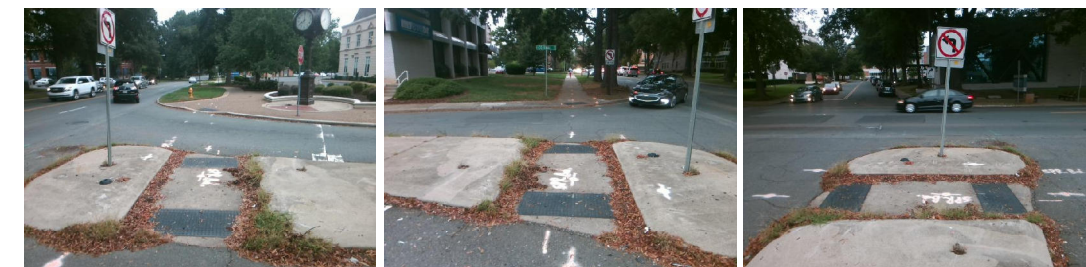
Compliance	Description	Data	Compliance	Description	Data
Yes	Refuge 1 Length (In)	69.0	N/A	Gutter 1 Ponding?	N/A
Yes	Refuge 1 Width (In)	72.0	N/A	Gutter 1 Lip Ht (In)	N/A
No	Refuge 1 Slope (%)	5.8	N/A	Gutter 1 Slope (%)	N/A
Yes	Refuge 1 X Slope (%)	0.1	N/A	Gutter 1 X Slope (%)	N/A
N/A	Painted X Walk1?	No	N/A	DWS 1 Provided?	N/A
N/A	X Walk 1 Direction	To NW	N/A	DWS 1 Contrast?	N/A
N/A	X Walk 1 Width (In)	N/A	N/A	DWS 1 Length (In)	N/A
N/A	Road 1 Slope (%)	1.1	N/A	DWS 1 Full Width?	N/A
N/A	Road 1 X Slope (%)	3.0	N/A	DWS 1 Offset (In)	N/A
Yes	Refuge 2 Length (In)	69.0	N/A	Gutter 2 Ponding?	N/A
Yes	Refuge 2 Width (In)	72.0	N/A	Gutter 2 Lip Ht (In)	N/A
Yes	Refuge 2 Slope (%)	2.7	N/A	Gutter 2 Slope (%)	N/A
Yes	Refuge 2 X Slope (%)	0.6	N/A	Gutter 2 X Slope (%)	N/A
N/A	Painted X Walk2?	No	N/A	DWS 2 Provided?	N/A
N/A	X Walk 2 Direction	To SE	N/A	DWS 2 Contrast?	N/A
N/A	X Walk 2 Width (In)	N/A	N/A	DWS 2 Length (In)	N/A

N/A	Road 2 Slope (%)	0.2	N/A	DWS 2 Full Width?	N/A
N/A	Road 2 X Slope (%)	2.3	N/A	DWS 2 Offset (In)	N/A
N/A	Refuge 3 Length (in)	N/A	N/A	Gutter 3 Ponding?	N/A
N/A	Refuge 3 Width (in)	N/A	N/A	Gutter 3 Lip Ht (in)	N/A
N/A	Refuge 3 Slope (%)	N/A	N/A	Gutter 3 Slope (%)	N/A
N/A	Refuge 3 XSlope (%)	N/A	N/A	Gutter 3 XSlope (%)	N/A
N/A	Painted X Walk3?	N/A	N/A	DWS 3 Provided?	N/A
N/A	X Walk 3 Direction	N/A	N/A	DWS 3 Contrast?	N/A
N/A	X Walk 3 Width (in)	N/A	N/A	DWS 3 Length (in)	N/A
N/A	Road 3 Slope (%)	N/A	N/A	DWS 3 Full Width?	N/A
N/A	Road 3 XSlope (%)	N/A	N/A	DWS 3 Offset (in)	N/A
Yes	Any Obstructions?	N/A	N/A	Storm Grate/Utility Hazard?	N/A
N/A	Obstruction Type		N/A	Storm Grate/Utility Type	
		N/A			N/A
N/A	Surface Condition	Good

Possible Solutions:

Remove & Replace Entire Refuge.
