Access Compliance Report

Public Rights-of-Way

(Island Curb Cuts)

Intersection ID: 21102	Main Street: S_TRYON_ST	Cross Street: AYRSLEY_TOWN_BV	Location: W
ADA ID: 74B31B1B9324	Curb Cut Type: MedianRefuge2	Initial Pass/Fail: Pass	Overall Compliance: No
Codes/Mitigation Info/Possible Solution		Field Measurements/Component Compliance	
Severity Score: 0

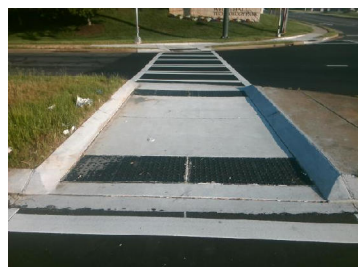
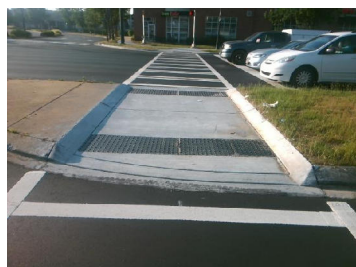
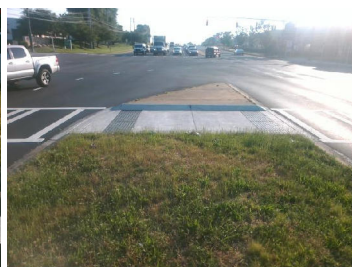
N/A	Road 2 Slope (%)	0.4	Yes	DWS 2 Full Width?	Yes
N/A	Road 2 X Slope (%)	2.5	No	DWS 2 Offset (In)	18.0
N/A	Refuge 3 Length (in)	N/A	N/A	Gutter 3 Ponding?	N/A
N/A	Refuge 3 Width (in)	N/A	N/A	Gutter 3 Lip Ht (in)	N/A
N/A	Refuge 3 Slope (%)	N/A	N/A	Gutter 3 Slope (%)	N/A
N/A	Refuge 3 XSlope (%)	N/A	N/A	Gutter 3 XSlope (%)	N/A
N/A	Painted X Walk3?	N/A	N/A	DWS 3 Provided?	N/A
N/A	X Walk 3 Direction	N/A	N/A	DWS 3 Contrast?	N/A
N/A	X Walk 3 Width (in)	N/A	N/A	DWS 3 Length (in)	N/A
N/A	Road 3 Slope (%)	N/A	N/A	DWS 3 Full Width?	N/A
N/A	Road 3 XSlope (%)	N/A	N/A	DWS 3 Offset (in)	N/A
Yes	Any Obstructions?	N/A	N/A	Storm Grate/Utility Hazard?	No
N/A	Obstruction Type		N/A	Storm Grate/Utility Type	
		N/A			N/A
N/A	Surface Condition	Good

Remove & Replace Detectable Warning System.
