# Access Compliance Report

## Public Rights-of-Way

### (Island Curb Cuts)

Intersection ID: 19730	Main Street: SOUTH_PARK_DR	Cross Street: MORRISON_BV	Location: SW
ADA ID: 74DA5CCB78D5	Curb Cut Type: IslandRefuge3	Initial Pass/Fail: Fail	Overall Compliance: No
Severity Score: 48.75			
Codes/Mitigation Info/Possible Solution		Field Measurements/Component Compliance

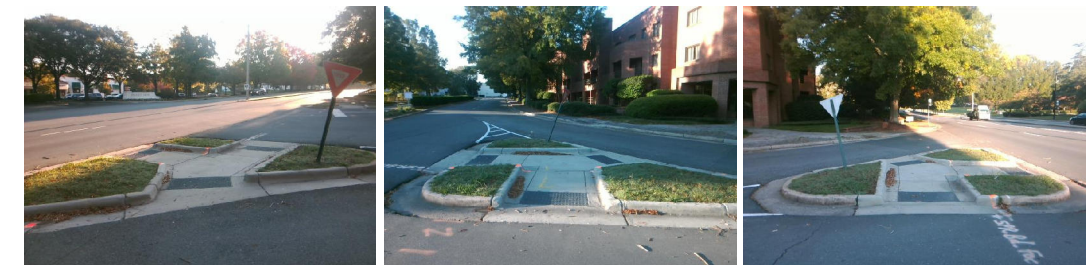
Compliance	Description	Data	Compliance	Description	Data
Yes	Refuge 1 Length (In)	58.0	N/A	Gutter 1 Ponding?	N/A
Yes	Refuge 1 Width (In)	62.0	N/A	Gutter 1 Lip Ht (In)	N/A
Yes	Refuge 1 Slope (%)	2.8	N/A	Gutter 1 Slope (%)	N/A
No	Refuge 1 X Slope (%)	5.1	N/A	Gutter 1 X Slope (%)	N/A
N/A	Painted X Walk1?	No	N/A	DWS 1 Provided?	N/A
N/A	X Walk 1 Direction	To SE	N/A	DWS 1 Contrast?	N/A
N/A	X Walk 1 Width (In)	N/A	N/A	DWS 1 Length (In)	N/A
N/A	Road 1 Slope (%)	5.7	N/A	DWS 1 Full Width?	N/A
N/A	Road 1 X Slope (%)	0.2	N/A	DWS 1 Offset (In)	N/A
Yes	Refuge 2 Length (In)	59.0	N/A	Gutter 2 Ponding?	N/A
Yes	Refuge 2 Width (In)	69.0	N/A	Gutter 2 Lip Ht (In)	N/A
Yes	Refuge 2 Slope (%)	1.3	N/A	Gutter 2 Slope (%)	N/A
Yes	Refuge 2 X Slope (%)	2.3	N/A	Gutter 2 X Slope (%)	N/A
N/A	Painted X Walk2?	No	N/A	DWS 2 Provided?	N/A
N/A	X Walk 2 Direction	To W	N/A	DWS 2 Contrast?	N/A
N/A	X Walk 2 Width (In)	N/A	N/A	DWS 2 Length (In)	N/A

N/A	Road 2 Slope (%)	3.7	N/A	DWS 2 Full Width?	N/A
N/A	Road 2 X Slope (%)	2.7	N/A	DWS 2 Offset (In)	N/A
Yes	Refuge 3 Length (in)	82.0	N/A	Gutter 3 Ponding?	N/A
Yes	Refuge 3 Width (in)	68.0	N/A	Gutter 3 Lip Ht (in)	N/A
Yes	Refuge 3 Slope (%)	3.3	N/A	Gutter 3 Slope (%)	N/A
Yes	Refuge 3 XSlope (%)	2.3	N/A	Gutter 3 XSlope (%)	N/A
N/A	Painted X Walk3?	No	N/A	DWS 3 Provided?	N/A
N/A	X Walk 3 Direction	To NE	N/A	DWS 3 Contrast?	N/A
N/A	X Walk 3 Width (in)	N/A	N/A	DWS 3 Length (in)	N/A
N/A	Road 3 Slope (%)	3.3	N/A	DWS 3 Full Width?	N/A
N/A	Road 3 XSlope (%)	3.9	N/A	DWS 3 Offset (in)	N/A
Yes	Any Obstructions?	N/A	N/A	Storm Grate/Utility Hazard?	N/A
N/A	Obstruction Type		N/A	Storm Grate/Utility Type	
		N/A			N/A
N/A	Surface Condition	Good

Possible Solutions:

**Remove & Replace Entire Refuge.**
