Access Compliance Report

Public Rights-of-Way

(Island Curb Cuts)

Intersection ID: 51054	Main Street: MULBERRY_CHURCH_RD	Cross Street: WESTPORT_RD	Location: SE
ADA ID: 794297AECE06	Curb Cut Type: MedianRefuge2	Initial Pass/Fail: Fail	Overall Compliance: No
Codes/Mitigation Info/Possible Solution		Field Measurements/Component Compliance	
Severity Score: 0

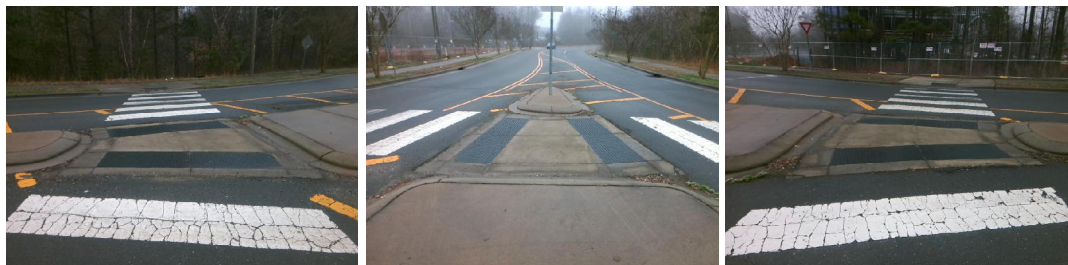
Compliance	Description	Data	Compliance	Description	Data
No	Refuge 1 Length (In)	30.0	N/A	Gutter 1 Ponding?	N/A
Yes	Refuge 1 Width (In)	136.0	N/A	Gutter 1 Lip Ht (In)	N/A
Yes	Refuge 1 Slope (%)	1.3	N/A	Gutter 1 Slope (%)	N/A
Yes	Refuge 1 X Slope (%)	0.9	N/A	Gutter 1 X Slope (%)	N/A
N/A	Painted X Walk1?	Yes	N/A	DWS 1 Provided?	N/A
N/A	X Walk 1 Direction	To E	N/A	DWS 1 Contrast?	N/A
N/A	X Walk 1 Width (In)	116.0	N/A	DWS 1 Length (In)	N/A
N/A	Road 1 Slope (%)	0.6	N/A	DWS 1 Full Width?	N/A
N/A	Road 1 X Slope (%)	0.0	N/A	DWS 1 Offset (In)	N/A
No	Refuge 2 Length (In)	30.0	N/A	Gutter 2 Ponding?	N/A
Yes	Refuge 2 Width (In)	136.0	N/A	Gutter 2 Lip Ht (In)	N/A
Yes	Refuge 2 Slope (%)	1.1	N/A	Gutter 2 Slope (%)	N/A
Yes	Refuge 2 X Slope (%)	2.1	N/A	Gutter 2 X Slope (%)	N/A
N/A	Painted X Walk2?	Yes	N/A	DWS 2 Provided?	N/A
N/A	X Walk 2 Direction	To W	N/A	DWS 2 Contrast?	N/A
N/A	X Walk 2 Width (In)	116.0	N/A	DWS 2 Length (In)	N/A

N/A	Road 2 Slope (%)	1.8	N/A	DWS 2 Full Width?	N/A
N/A	Road 2 X Slope (%)	0.8	N/A	DWS 2 Offset (In)	N/A
N/A	Refuge 3 Length (in)	N/A	N/A	Gutter 3 Ponding?	N/A
N/A	Refuge 3 Width (in)	N/A	N/A	Gutter 3 Lip Ht (in)	N/A
N/A	Refuge 3 Slope (%)	N/A	N/A	Gutter 3 Slope (%)	N/A
N/A	Refuge 3 XSlope (%)	N/A	N/A	Gutter 3 XSlope (%)	N/A
N/A	Painted X Walk3?	N/A	N/A	DWS 3 Provided?	N/A
N/A	X Walk 3 Direction	N/A	N/A	DWS 3 Contrast?	N/A
N/A	X Walk 3 Width (in)	N/A	N/A	DWS 3 Length (in)	N/A
N/A	Road 3 Slope (%)	N/A	N/A	DWS 3 Full Width?	N/A
N/A	Road 3 XSlope (%)	N/A	N/A	DWS 3 Offset (in)	N/A
Yes	Any Obstructions?	N/A	N/A	Storm Grate/Utility Hazard?	N/A
N/A	Obstruction Type		N/A	Storm Grate/Utility Type	
		N/A			N/A
N/A	Surface Condition	Good

Possible Solutions:

Remove & Replace Entire Refuge.

Total Cost: \$ 3000.00
