Access Compliance Report Public Rights-of-Way (Island Curb Cuts)

Intersection ID: 5966	Main Street: SUNSTONE_DR	Cross Street: STATESVILLE_RD	Location: N
ADA ID: 794988D32590	Curb Cut Type: MedianRefuge2	Initial Pass/Fail: Pass	Overall Compliance: No Severity Score: 7.75

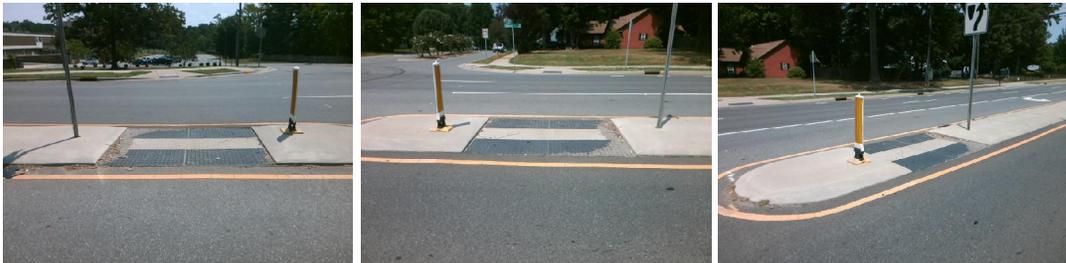
Compliance	Description	Data	Compliance	Description	Data
No	Refuge 1 Length (In)	35.5	No	Gutter 1 Ponding?	Yes
Yes	Refuge 1 Width (In)	95.5	No	Gutter 1 Lip Ht (In)	0.5
Yes	Refuge 1 Slope (%)	1.6	Yes	Gutter 1 Slope (%)	1.9
Yes	Refuge 1 X Slope (%)	1.4	Yes	Gutter 1 X Slope (%)	1.0
N/A	Painted X Walk1?	No	No	DWS 1 Provided?	Yes
N/A	X Walk 1 Direction	To W	N/A	DWS 1 Contrast?	Yes
N/A	X Walk 1 Width (In)	N/A	N/A	DWS 1 Length (In)	24.0
N/A	Road 1 Slope (%)	1.0	N/A	DWS 1 Full Width?	Yes
N/A	Road 1 X Slope (%)	0.8	N/A	DWS 1 Offset (In)	0.0
No	Refuge 2 Length (In)	35.5	No	Gutter 2 Ponding?	Yes
Yes	Refuge 2 Width (In)	95.5	No	Gutter 2 Lip Ht (In)	0.5
Yes	Refuge 2 Slope (%)	2.9	Yes	Gutter 2 Slope (%)	3.0
Yes	Refuge 2 X Slope (%)	0.7	Yes	Gutter 2 X Slope (%)	1.6
N/A	Painted X Walk2?	No	No	DWS 2 Provided?	Yes
N/A	X Walk 2 Direction	To NE	N/A	DWS 2 Contrast?	Yes
N/A	X Walk 2 Width (In)	N/A	N/A	DWS 2 Length (In)	24.0
N/A	Road 2 Slope (%)	1.0	N/A	DWS 2 Full Width?	Yes

N/A	Road 2 X Slope (%)	2.7	N/A	DWS 2 Offset (In)	0.0
N/A	Refuge 3 Length (in)	N/A	N/A	Gutter 3 Ponding?	No
N/A	Refuge 3 Width (in)	N/A	N/A	Gutter 3 Lip Ht (in)	N/A
N/A	Refuge 3 Slope (%)	N/A	N/A	Gutter 3 Slope (%)	N/A
N/A	Refuge 3 XSlope (%)	N/A	N/A	Gutter 3 XSlope (%)	N/A
N/A	Painted X Walk3?	No	N/A	DWS 3 Provided?	N/A
N/A	X Walk 3 Direction	N/A	N/A	DWS 3 Contrast?	N/A
N/A	X Walk 3 Width (in)	N/A	N/A	DWS 3 Length (in)	N/A
N/A	Road 3 Slope (%)	N/A	N/A	DWS 3 Full Width?	N/A
N/A	Road 3 XSlope (%)	N/A	N/A	DWS 3 Offset (in)	N/A
Yes	Any Obstructions?	No	N/A	Storm Grate/Utility Hazard?	No
N/A	Obstruction Type		N/A	Storm Grate/Utility Type	
			N/A		N/A
N/A	Surface Condition	Good

Possible Solutions:
**Remove & Replace Entire Refuge.
Grind Gutter Lip.**

Total Cost: \$ **3400.00**
