Access Compliance Report

Public Rights-of-Way

(Island Curb Cuts)

Intersection ID: 43075	Main Street: SCOTT_AV	Cross Street: ROMANY_RD	Location: S
ADA ID: 7BD5E708D563	Curb Cut Type: IslandRefuge3	Initial Pass/Fail: Fail	Overall Compliance: No
Severity Score: 60			
Codes/Mitigation Info/Possible Solution		Field Measurements/Component Compliance

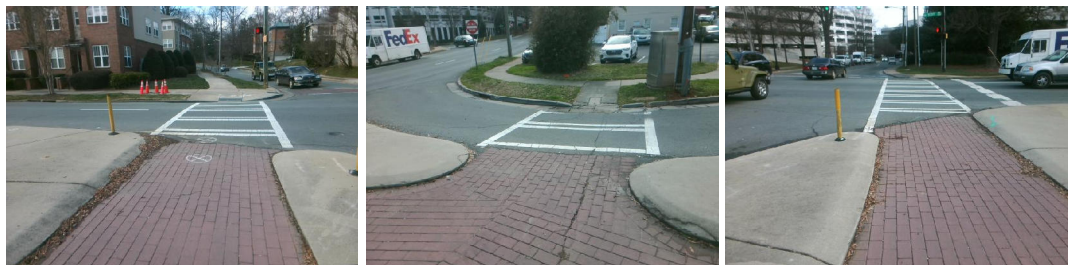
Compliance	Description	Data	Compliance	Description	Data
Yes	Refuge 1 Length (In)	206.0	N/A	Gutter 1 Ponding?	N/A
Yes	Refuge 1 Width (In)	96.0	N/A	Gutter 1 Lip Ht (In)	N/A
Yes	Refuge 1 Slope (%)	3.3	N/A	Gutter 1 Slope (%)	N/A
Yes	Refuge 1 X Slope (%)	2.3	N/A	Gutter 1 X Slope (%)	N/A
N/A	Painted X Walk1?	Yes	N/A	DWS 1 Provided?	N/A
N/A	X Walk 1 Direction	To W	N/A	DWS 1 Contrast?	N/A
N/A	X Walk 1 Width (In)	109.0	N/A	DWS 1 Length (In)	N/A
N/A	Road 1 Slope (%)	1.1	N/A	DWS 1 Full Width?	N/A
N/A	Road 1 X Slope (%)	1.2	N/A	DWS 1 Offset (In)	N/A
Yes	Refuge 2 Length (In)	158.0	N/A	Gutter 2 Ponding?	N/A
Yes	Refuge 2 Width (In)	96.0	N/A	Gutter 2 Lip Ht (In)	N/A
Yes	Refuge 2 Slope (%)	1.8	N/A	Gutter 2 Slope (%)	N/A
Yes	Refuge 2 X Slope (%)	2.7	N/A	Gutter 2 X Slope (%)	N/A
N/A	Painted X Walk2?	Yes	N/A	DWS 2 Provided?	N/A
N/A	X Walk 2 Direction	To E	N/A	DWS 2 Contrast?	N/A
N/A	X Walk 2 Width (In)	106.0	N/A	DWS 2 Length (In)	N/A

N/A	Road 2 Slope (%)	2.6	N/A	DWS 2 Full Width?	N/A
N/A	Road 2 X Slope (%)	1.2	N/A	DWS 2 Offset (In)	N/A
Yes	Refuge 3 Length (in)	55.0	N/A	Gutter 3 Ponding?	N/A
Yes	Refuge 3 Width (in)	96.0	N/A	Gutter 3 Lip Ht (in)	N/A
No	Refuge 3 Slope (%)	7.0	N/A	Gutter 3 Slope (%)	N/A
Yes	Refuge 3 XSlope (%)	0.3	N/A	Gutter 3 XSlope (%)	N/A
N/A	Painted X Walk3?	Yes	N/A	DWS 3 Provided?	N/A
N/A	X Walk 3 Direction	To S	N/A	DWS 3 Contrast?	N/A
N/A	X Walk 3 Width (in)	113.0	N/A	DWS 3 Length (in)	N/A
N/A	Road 3 Slope (%)	1.0	N/A	DWS 3 Full Width?	N/A
N/A	Road 3 XSlope (%)	9.0	N/A	DWS 3 Offset (in)	N/A
Yes	Any Obstructions?	N/A	N/A	Storm Grate/Utility Hazard?	N/A
N/A	Obstruction Type		N/A	Storm Grate/Utility Type	
			N/A		N/A
N/A	Surface Condition	Good

Possible Solutions:

Remove & Replace Entire Refuge.
