Access Compliance Report

Public Rights-of-Way

(Island Curb Cuts)

Intersection ID: 44555	Main Street: UNIVERSITY_CITY_BV	Cross Street: N_TRYON_ST	Location: SW
ADA ID: 7D7475358BB7	Curb Cut Type: IslandRefuge3	Initial Pass/Fail: Fail	Overall Compliance: No
Codes/Mitigation Info/Possible Solution		Field Measurements/Component Compliance

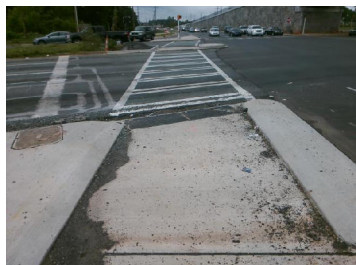
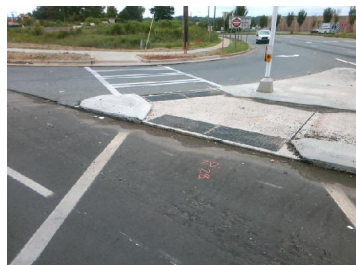
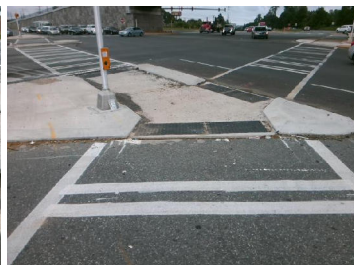
Compliance	Description	Data	Compliance	Description	Data
No	Refuge 1 Length (In)	144.0	Yes	Gutter 1 Ponding?	N/A
Yes	Refuge 1 Width (In)	95.0	No	Gutter 1 Lip Ht (In)	2.0
Yes	Refuge 1 Slope (%)	1.6	No	Gutter 1 Slope (%)	N/A
Yes	Refuge 1 X Slope (%)	2.7	No	Gutter 1 X Slope (%)	N/A
N/A	Painted X Walk1?	Yes	N/A	DWS 1 Provided?	N/A
N/A	X Walk 1 Direction	To NE	N/A	DWS 1 Contrast?	N/A
N/A	X Walk 1 Width (In)	125.0	N/A	DWS 1 Length (In)	N/A
N/A	Road 1 Slope (%)	3.4	N/A	DWS 1 Full Width?	N/A
N/A	Road 1 X Slope (%)	3.5	N/A	DWS 1 Offset (In)	N/A
No	Refuge 2 Length (In)	30.0	Yes	Gutter 2 Ponding?	N/A
Yes	Refuge 2 Width (In)	110.0	No	Gutter 2 Lip Ht (In)	2.0
Yes	Refuge 2 Slope (%)	3.2	No	Gutter 2 Slope (%)	N/A
Yes	Refuge 2 X Slope (%)	0.9	No	Gutter 2 X Slope (%)	N/A
N/A	Painted X Walk2?	Yes	N/A	DWS 2 Provided?	N/A
N/A	X Walk 2 Direction	To E	N/A	DWS 2 Contrast?	N/A
N/A	X Walk 2 Width (In)	120.0	N/A	DWS 2 Length (In)	N/A

N/A	Road 2 Slope (%)	0.2	N/A	DWS 2 Full Width?	N/A
N/A	Road 2 X Slope (%)	2.8	N/A	DWS 2 Offset (In)	N/A
No	Refuge 3 Length (in)	40.0	Yes	Gutter 3 Ponding?	N/A
Yes	Refuge 3 Width (in)	94.0	No	Gutter 3 Lip Ht (in)	2.0
Yes	Refuge 3 Slope (%)	1.3	No	Gutter 3 Slope (%)	N/A
Yes	Refuge 3 XSlope (%)	2.3	No	Gutter 3 XSlope (%)	N/A
N/A	Painted X Walk3?	Yes	N/A	DWS 3 Provided?	N/A
N/A	X Walk 3 Direction	To SW	N/A	DWS 3 Contrast?	N/A
N/A	X Walk 3 Width (in)	120.0	N/A	DWS 3 Length (in)	N/A
N/A	Road 3 Slope (%)	3.2	N/A	DWS 3 Full Width?	N/A
N/A	Road 3 XSlope (%)	1.5	N/A	DWS 3 Offset (in)	N/A
Yes	Any Obstructions?	N/A	N/A	Storm Grate/Utility Hazard?	N/A
N/A	Obstruction Type		N/A	Storm Grate/Utility Type	
			N/A		N/A
N/A	Surface Condition	Good

Remove & Replace Entire Refuge.
Remove & Replace Gutter.
