Access Compliance Report

Public Rights-of-Way

(Island Curb Cuts)

Intersection ID: 11108	Main Street: TUCKASEEGEE_RD	Cross Street: BERRYHILL_RD	Location:	N
ADA ID: 7E0C7CF7F7C7	Curb Cut Type: MedianRefuge2	Initial Pass/Fail: Fail	Overall Compliance: No	Severity Score: 10
Codes/Mitigation Info/Possible Solution		Field Measurements/Component Compliance

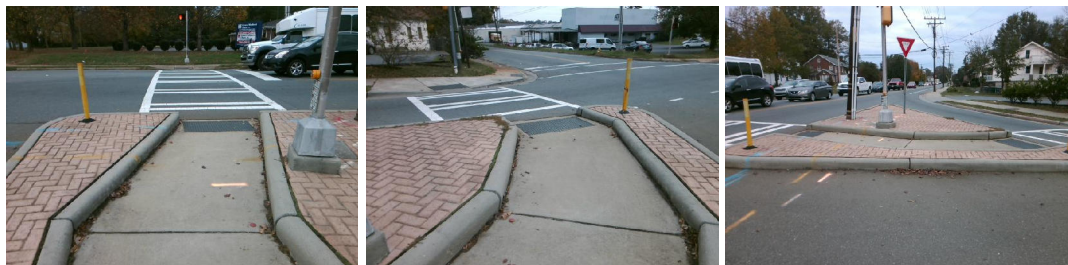
Compliance	Description	Data	Compliance	Description	Data
Yes	Refuge 1 Length (In)	115.5	N/A	Gutter 1 Ponding?	N/A
No	Refuge 1 Width (In)	58.5	N/A	Gutter 1 Lip Ht (In)	N/A
Yes	Refuge 1 Slope (%)	0.6	N/A	Gutter 1 Slope (%)	N/A
Yes	Refuge 1 X Slope (%)	2.4	N/A	Gutter 1 X Slope (%)	N/A
N/A	Painted X Walk1?	Yes	N/A	DWS 1 Provided?	N/A
N/A	X Walk 1 Direction	To W	N/A	DWS 1 Contrast?	N/A
N/A	X Walk 1 Width (In)	111.0	N/A	DWS 1 Length (In)	N/A
N/A	Road 1 Slope (%)	2.0	N/A	DWS 1 Full Width?	N/A
N/A	Road 1 X Slope (%)	4.7	N/A	DWS 1 Offset (In)	N/A
Yes	Refuge 2 Length (In)	115.5	N/A	Gutter 2 Ponding?	N/A
No	Refuge 2 Width (In)	58.5	N/A	Gutter 2 Lip Ht (In)	N/A
Yes	Refuge 2 Slope (%)	2.5	N/A	Gutter 2 Slope (%)	N/A
Yes	Refuge 2 X Slope (%)	2.2	N/A	Gutter 2 X Slope (%)	N/A
N/A	Painted X Walk2?	Yes	N/A	DWS 2 Provided?	N/A
N/A	X Walk 2 Direction	To E	N/A	DWS 2 Contrast?	N/A
N/A	X Walk 2 Width (In)	109.0	N/A	DWS 2 Length (In)	N/A

N/A	Road 2 Slope (%)	3.8	N/A	DWS 2 Full Width?	N/A
N/A	Road 2 X Slope (%)	4.7	N/A	DWS 2 Offset (In)	N/A
N/A	Refuge 3 Length (in)	N/A	N/A	Gutter 3 Ponding?	N/A
N/A	Refuge 3 Width (in)	N/A	N/A	Gutter 3 Lip Ht (in)	N/A
N/A	Refuge 3 Slope (%)	N/A	N/A	Gutter 3 Slope (%)	N/A
N/A	Refuge 3 XSlope (%)	N/A	N/A	Gutter 3 XSlope (%)	N/A
N/A	Painted X Walk3?	N/A	N/A	DWS 3 Provided?	N/A
N/A	X Walk 3 Direction	N/A	N/A	DWS 3 Contrast?	N/A
N/A	X Walk 3 Width (in)	N/A	N/A	DWS 3 Length (in)	N/A
N/A	Road 3 Slope (%)	N/A	N/A	DWS 3 Full Width?	N/A
N/A	Road 3 XSlope (%)	N/A	N/A	DWS 3 Offset (in)	N/A
Yes	Any Obstructions?	N/A	N/A	Storm Grate/Utility Hazard?	N/A
N/A	Obstruction Type		N/A	Storm Grate/Utility Type	
		N/A			N/A
N/A	Surface Condition	Good

Remove & Replace Entire Refuge.
