# Access Compliance Report

## Public Rights-of-Way

### (Island Curb Cuts)

Intersection ID: 15806	Main Street: EAST_BV	Cross Street: MARYLAND_AV	Location: NW
ADA ID: 7E57172E1A03	Curb Cut Type: MedianRefuge2	Initial Pass/Fail: Fail	Overall Compliance: No
Severity Score: 0			
Codes/Mitigation Info/Possible Solution		Field Measurements/Component Compliance

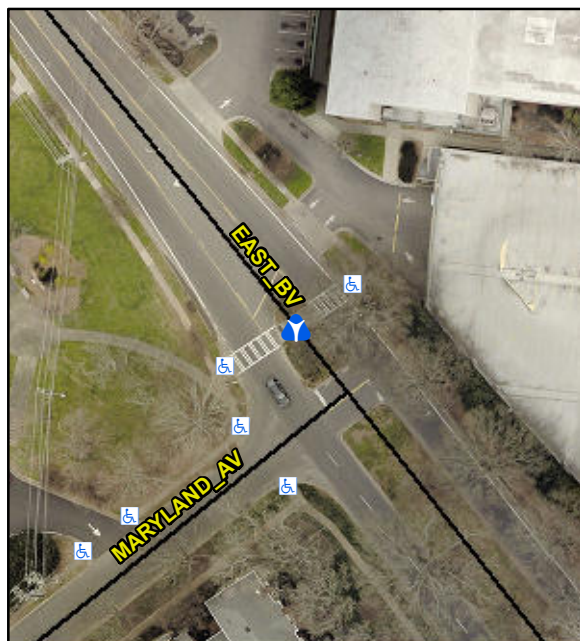
Compliance	Description	Data	Compliance	Description	Data
Yes	Refuge 1 Length (In)	114.5	N/A	Gutter 1 Ponding?	N/A
Yes	Refuge 1 Width (In)	94.0	N/A	Gutter 1 Lip Ht (In)	N/A
Yes	Refuge 1 Slope (%)	0.3	N/A	Gutter 1 Slope (%)	N/A
Yes	Refuge 1 X Slope (%)	2.3	N/A	Gutter 1 X Slope (%)	N/A
N/A	Painted X Walk1?	Yes	N/A	DWS 1 Provided?	N/A
N/A	X Walk 1 Direction	To SW	N/A	DWS 1 Contrast?	N/A
N/A	X Walk 1 Width (In)	111.0	N/A	DWS 1 Length (In)	N/A
N/A	Road 1 Slope (%)	1.6	N/A	DWS 1 Full Width?	N/A
N/A	Road 1 X Slope (%)	1.1	N/A	DWS 1 Offset (In)	N/A
Yes	Refuge 2 Length (In)	114.5	N/A	Gutter 2 Ponding?	N/A
Yes	Refuge 2 Width (In)	94.0	N/A	Gutter 2 Lip Ht (In)	N/A
Yes	Refuge 2 Slope (%)	1.3	N/A	Gutter 2 Slope (%)	N/A
Yes	Refuge 2 X Slope (%)	0.7	N/A	Gutter 2 X Slope (%)	N/A
N/A	Painted X Walk2?	Yes	N/A	DWS 2 Provided?	N/A
N/A	X Walk 2 Direction	To NE	N/A	DWS 2 Contrast?	N/A
N/A	X Walk 2 Width (In)	111.0	N/A	DWS 2 Length (In)	N/A

N/A	Road 2 Slope (%)	0.0	N/A	DWS 2 Full Width?	N/A
N/A	Road 2 X Slope (%)	0.7	N/A	DWS 2 Offset (In)	N/A
N/A	Refuge 3 Length (in)	N/A	N/A	Gutter 3 Ponding?	N/A
N/A	Refuge 3 Width (in)	N/A	N/A	Gutter 3 Lip Ht (in)	N/A
N/A	Refuge 3 Slope (%)	N/A	N/A	Gutter 3 Slope (%)	N/A
N/A	Refuge 3 XSlope (%)	N/A	N/A	Gutter 3 XSlope (%)	N/A
N/A	Painted X Walk3?	N/A	N/A	DWS 3 Provided?	N/A
N/A	X Walk 3 Direction	N/A	N/A	DWS 3 Contrast?	N/A
N/A	X Walk 3 Width (in)	N/A	N/A	DWS 3 Length (in)	N/A
N/A	Road 3 Slope (%)	N/A	N/A	DWS 3 Full Width?	N/A
N/A	Road 3 XSlope (%)	N/A	N/A	DWS 3 Offset (in)	N/A
Yes	Any Obstructions?	N/A	N/A	Storm Grate/Utility Hazard?	N/A
N/A	Obstruction Type		N/A	Storm Grate/Utility Type	
		N/A			N/A
N/A	Surface Condition	Good

Possible Solutions:

**Remove & Replace Entire Refuge.**
