Access Compliance Report

Public Rights-of-Way

(Island Curb Cuts)

Intersection ID: 6611	Main Street: N_TRYON_ST	Cross Street: W_ROCKY_RIVER_RD	Location: SE
ADA ID: 7EEDD4093FA0	Curb Cut Type: MedianRefuge2	Initial Pass/Fail: Pass	Overall Compliance: No
Severity Score: 0			
Codes/Mitigation Info/Possible Solution		Field Measurements/Component Compliance

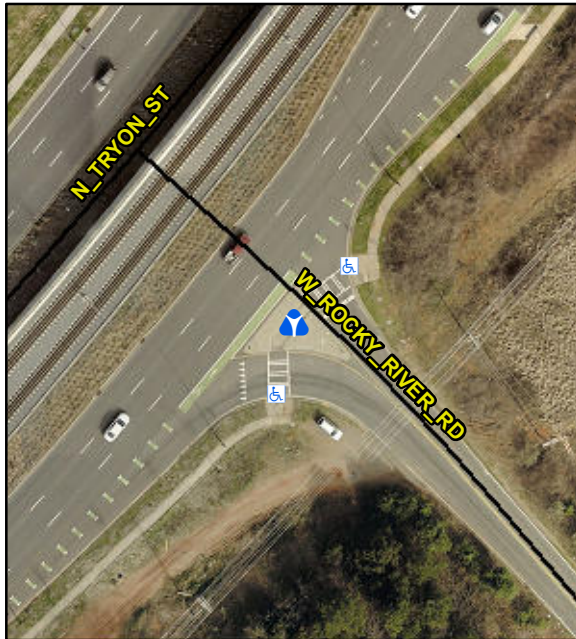
N/A	Road 2 Slope (%)	0.3	Yes	DWS 2 Full Width?	Yes
N/A	Road 2 X Slope (%)	1.6	No	DWS 2 Offset (In)	3.5
N/A	Refuge 3 Length (in)	N/A	N/A	Gutter 3 Ponding?	N/A
N/A	Refuge 3 Width (in)	N/A	N/A	Gutter 3 Lip Ht (in)	N/A
N/A	Refuge 3 Slope (%)	N/A	N/A	Gutter 3 Slope (%)	N/A
N/A	Refuge 3 XSlope (%)	N/A	N/A	Gutter 3 XSlope (%)	N/A
N/A	Painted X Walk3?	N/A	N/A	DWS 3 Provided?	N/A
N/A	X Walk 3 Direction	N/A	N/A	DWS 3 Contrast?	N/A
N/A	X Walk 3 Width (in)	N/A	N/A	DWS 3 Length (in)	N/A
N/A	Road 3 Slope (%)	N/A	N/A	DWS 3 Full Width?	N/A
N/A	Road 3 XSlope (%)	N/A	N/A	DWS 3 Offset (in)	N/A
Yes	Any Obstructions?	N/A	N/A	Storm Grate/Utility Hazard?	No
N/A	Obstruction Type		N/A	Storm Grate/Utility Type	
		N/A			N/A
N/A	Surface Condition	Good

Possible Solutions:

Remove & Replace Detectable Warning System.
