Access Compliance Report

Public Rights-of-Way

(Island Curb Cuts)

Intersection ID: 12013	Main Street: FREEDOM_DR	Cross Street: W_MOREHEAD_ST	Location: W
ADA ID: 80B39F8427D8	Curb Cut Type: MedianRefuge2	Initial Pass/Fail: Fail	Overall Compliance: No
Codes/Mitigation Info/Possible Solution		Field Measurements/Component Compliance	
Severity Score: 12.5

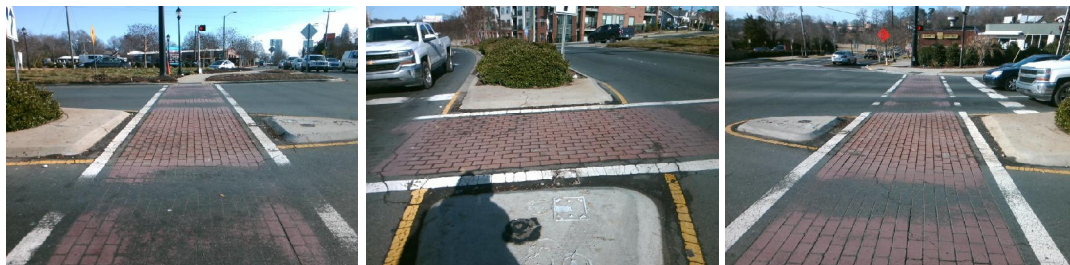
Compliance	Description	Data	Compliance	Description	Data
Yes	Refuge 1 Length (In)	36.0	N/A	Gutter 1 Ponding?	N/A
Yes	Refuge 1 Width (In)	144.0	N/A	Gutter 1 Lip Ht (In)	N/A
No	Refuge 1 Slope (%)	6.4	N/A	Gutter 1 Slope (%)	N/A
Yes	Refuge 1 X Slope (%)	1.9	N/A	Gutter 1 X Slope (%)	N/A
N/A	Painted X Walk1?	Yes	N/A	DWS 1 Provided?	N/A
N/A	X Walk 1 Direction	To W	N/A	DWS 1 Contrast?	N/A
N/A	X Walk 1 Width (In)	114.0	N/A	DWS 1 Length (In)	N/A
N/A	Road 1 Slope (%)	1.6	N/A	DWS 1 Full Width?	N/A
N/A	Road 1 X Slope (%)	9.3	N/A	DWS 1 Offset (In)	N/A
Yes	Refuge 2 Length (In)	36.0	N/A	Gutter 2 Ponding?	N/A
Yes	Refuge 2 Width (In)	140.0	N/A	Gutter 2 Lip Ht (In)	N/A
No	Refuge 2 Slope (%)	6.1	N/A	Gutter 2 Slope (%)	N/A
Yes	Refuge 2 X Slope (%)	1.9	N/A	Gutter 2 X Slope (%)	N/A
N/A	Painted X Walk2?	Yes	N/A	DWS 2 Provided?	N/A
N/A	X Walk 2 Direction	To E	N/A	DWS 2 Contrast?	N/A
N/A	X Walk 2 Width (In)	114.0	N/A	DWS 2 Length (In)	N/A

N/A	Road 2 Slope (%)	1.1	N/A	DWS 2 Full Width?	N/A
N/A	Road 2 X Slope (%)	6.6	N/A	DWS 2 Offset (In)	N/A
N/A	Refuge 3 Length (in)	N/A	N/A	Gutter 3 Ponding?	N/A
N/A	Refuge 3 Width (in)	N/A	N/A	Gutter 3 Lip Ht (in)	N/A
N/A	Refuge 3 Slope (%)	N/A	N/A	Gutter 3 Slope (%)	N/A
N/A	Refuge 3 XSlope (%)	N/A	N/A	Gutter 3 XSlope (%)	N/A
N/A	Painted X Walk3?	N/A	N/A	DWS 3 Provided?	N/A
N/A	X Walk 3 Direction	N/A	N/A	DWS 3 Contrast?	N/A
N/A	X Walk 3 Width (in)	N/A	N/A	DWS 3 Length (in)	N/A
N/A	Road 3 Slope (%)	N/A	N/A	DWS 3 Full Width?	N/A
N/A	Road 3 XSlope (%)	N/A	N/A	DWS 3 Offset (in)	N/A
Yes	Any Obstructions?	N/A	N/A	Storm Grate/Utility Hazard?	N/A
N/A	Obstruction Type		N/A	Storm Grate/Utility Type	
			N/A		N/A
N/A	Surface Condition	Good

Possible Solutions:

Remove & Replace Entire Refuge.
