Access Compliance Report

Public Rights-of-Way

(Island Curb Cuts)

Intersection ID: 10033070	Main Street: NORTH_COMMUNITY_HOUSE_RD	Cross Street: N/A	Location: N
ADA ID: 81F825E3B9B9	Curb Cut Type: MedianRefuge2	Initial Pass/Fail: Fail	Overall Compliance: No
Codes/Mitigation Info/Possible Solution		Field Measurements/Component Compliance

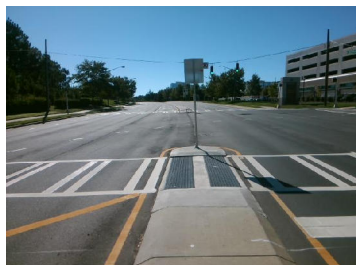
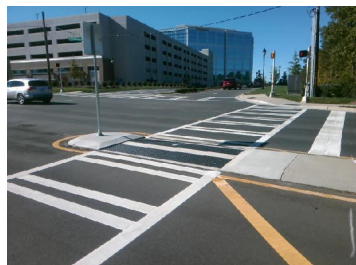
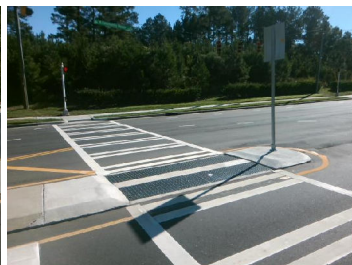
Compliance	Description	Data	Compliance	Description	Data
No	Refuge 1 Length (In)	34.5	N/A	Gutter 1 Ponding?	N/A
Yes	Refuge 1 Width (In)	120.0	N/A	Gutter 1 Lip Ht (In)	N/A
No	Refuge 1 Slope (%)	5.9	N/A	Gutter 1 Slope (%)	N/A
Yes	Refuge 1 X Slope (%)	2.9	N/A	Gutter 1 X Slope (%)	N/A
N/A	Painted X Walk1?	Yes	N/A	DWS 1 Provided?	N/A
N/A	X Walk 1 Direction	To E	N/A	DWS 1 Contrast?	N/A
N/A	X Walk 1 Width (In)	110.0	N/A	DWS 1 Length (In)	N/A
N/A	Road 1 Slope (%)	3.7	N/A	DWS 1 Full Width?	N/A
N/A	Road 1 X Slope (%)	5.0	N/A	DWS 1 Offset (In)	N/A
No	Refuge 2 Length (In)	34.5	N/A	Gutter 2 Ponding?	N/A
Yes	Refuge 2 Width (In)	120.0	N/A	Gutter 2 Lip Ht (In)	N/A
Yes	Refuge 2 Slope (%)	1.6	N/A	Gutter 2 Slope (%)	N/A
Yes	Refuge 2 X Slope (%)	3.4	N/A	Gutter 2 X Slope (%)	N/A
N/A	Painted X Walk2?	Yes	N/A	DWS 2 Provided?	N/A
N/A	X Walk 2 Direction	To W	N/A	DWS 2 Contrast?	N/A
N/A	X Walk 2 Width (In)	110.0	N/A	DWS 2 Length (In)	N/A

N/A	Road 2 Slope (%)	3.3	N/A	DWS 2 Full Width?	N/A
N/A	Road 2 X Slope (%)	2.1	N/A	DWS 2 Offset (In)	N/A
N/A	Refuge 3 Length (in)	N/A	N/A	Gutter 3 Ponding?	N/A
N/A	Refuge 3 Width (in)	N/A	N/A	Gutter 3 Lip Ht (in)	N/A
N/A	Refuge 3 Slope (%)	N/A	N/A	Gutter 3 Slope (%)	N/A
N/A	Refuge 3 XSlope (%)	N/A	N/A	Gutter 3 XSlope (%)	N/A
N/A	Painted X Walk3?	N/A	N/A	DWS 3 Provided?	N/A
N/A	X Walk 3 Direction	N/A	N/A	DWS 3 Contrast?	N/A
N/A	X Walk 3 Width (in)	N/A	N/A	DWS 3 Length (in)	N/A
N/A	Road 3 Slope (%)	N/A	N/A	DWS 3 Full Width?	N/A
N/A	Road 3 XSlope (%)	N/A	N/A	DWS 3 Offset (in)	N/A
Yes	Any Obstructions?	N/A	N/A	Storm Grate/Utility Hazard?	N/A
N/A	Obstruction Type		N/A	Storm Grate/Utility Type	
		N/A			N/A
N/A	Surface Condition	Good

Possible Solutions:

Remove & Replace Entire Refuge.
