Access Compliance Report

Public Rights-of-Way

(Island Curb Cuts)

Intersection ID: 7031	Main Street: BROOKSHIRE_BV	Cross Street: OAKDALE_RD	Location: NE
ADA ID: 823868A561C6	Curb Cut Type: MedianRefuge2	Initial Pass/Fail: Pass	Overall Compliance: No
Codes/Mitigation Info/Possible Solution		Field Measurements/Component Compliance	
Severity Score: 0

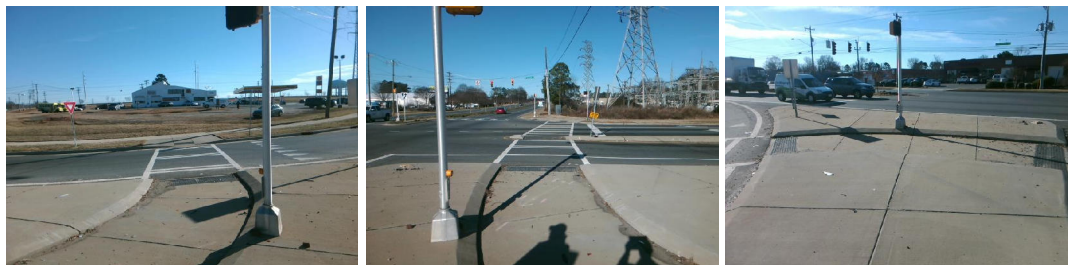
N/A	Road 2 Slope (%)	1.3	Yes	DWS 2 Full Width?	Yes
N/A	Road 2 X Slope (%)	1.9	No	DWS 2 Offset (In)	4.5
N/A	Refuge 3 Length (in)	N/A	N/A	Gutter 3 Ponding?	N/A
N/A	Refuge 3 Width (in)	N/A	N/A	Gutter 3 Lip Ht (in)	N/A
N/A	Refuge 3 Slope (%)	N/A	N/A	Gutter 3 Slope (%)	N/A
N/A	Refuge 3 XSlope (%)	N/A	N/A	Gutter 3 XSlope (%)	N/A
N/A	Painted X Walk3?	N/A	N/A	DWS 3 Provided?	N/A
N/A	X Walk 3 Direction	N/A	N/A	DWS 3 Contrast?	N/A
N/A	X Walk 3 Width (in)	N/A	N/A	DWS 3 Length (in)	N/A
N/A	Road 3 Slope (%)	N/A	N/A	DWS 3 Full Width?	N/A
N/A	Road 3 XSlope (%)	N/A	N/A	DWS 3 Offset (in)	N/A
Yes	Any Obstructions?	No	N/A	Storm Grate/Utility Hazard?	No
N/A	Obstruction Type		N/A	Storm Grate/Utility Type	
		N/A			N/A
N/A	Surface Condition	Good

Remove & Replace Detectable Warning System.
