Access Compliance Report

Public Rights-of-Way

(Island Curb Cuts)

Intersection ID: 13404	Main Street: LEXINGTON_AV	Cross Street: E_CARSON_BV	Location: SW
ADA ID: 82F988EDC268	Curb Cut Type: MedianRefuge2	Initial Pass/Fail: Fail	Overall Compliance: No
Severity Score: 10			
Codes/Mitigation Info/Possible Solution		Field Measurements/Component Compliance

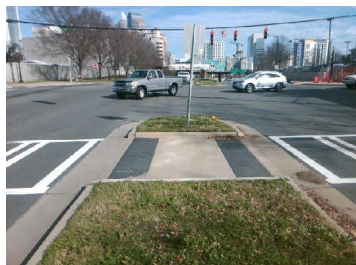
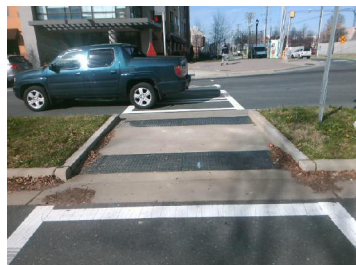
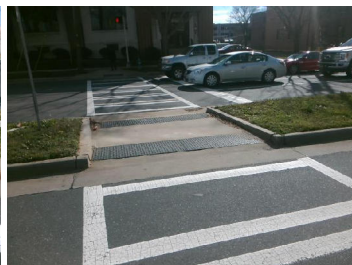
Compliance	Description	Data	Compliance	Description	Data
Yes	Refuge 1 Length (In)	54.0	N/A	Gutter 1 Ponding?	N/A
No	Refuge 1 Width (In)	54.0	N/A	Gutter 1 Lip Ht (In)	N/A
Yes	Refuge 1 Slope (%)	2.3	N/A	Gutter 1 Slope (%)	N/A
Yes	Refuge 1 X Slope (%)	2.6	N/A	Gutter 1 X Slope (%)	N/A
N/A	Painted X Walk1?	Yes	N/A	DWS 1 Provided?	N/A
N/A	X Walk 1 Direction	To NW	N/A	DWS 1 Contrast?	N/A
N/A	X Walk 1 Width (In)	113.0	N/A	DWS 1 Length (In)	N/A
N/A	Road 1 Slope (%)	2.6	N/A	DWS 1 Full Width?	N/A
N/A	Road 1 X Slope (%)	1.3	N/A	DWS 1 Offset (In)	N/A
Yes	Refuge 2 Length (In)	118.0	N/A	Gutter 2 Ponding?	N/A
Yes	Refuge 2 Width (In)	118.0	N/A	Gutter 2 Lip Ht (In)	N/A
Yes	Refuge 2 Slope (%)	4.8	N/A	Gutter 2 Slope (%)	N/A
Yes	Refuge 2 X Slope (%)	1.5	N/A	Gutter 2 X Slope (%)	N/A
N/A	Painted X Walk2?	Yes	N/A	DWS 2 Provided?	N/A
N/A	X Walk 2 Direction	To SE	N/A	DWS 2 Contrast?	N/A
N/A	X Walk 2 Width (In)	111.0	N/A	DWS 2 Length (In)	N/A

N/A	Road 2 Slope (%)	1.6	N/A	DWS 2 Full Width?	N/A
N/A	Road 2 X Slope (%)	3.1	N/A	DWS 2 Offset (In)	N/A
N/A	Refuge 3 Length (in)	N/A	N/A	Gutter 3 Ponding?	N/A
N/A	Refuge 3 Width (in)	N/A	N/A	Gutter 3 Lip Ht (in)	N/A
N/A	Refuge 3 Slope (%)	N/A	N/A	Gutter 3 Slope (%)	N/A
N/A	Refuge 3 XSlope (%)	N/A	N/A	Gutter 3 XSlope (%)	N/A
N/A	Painted X Walk3?	N/A	N/A	DWS 3 Provided?	N/A
N/A	X Walk 3 Direction	N/A	N/A	DWS 3 Contrast?	N/A
N/A	X Walk 3 Width (in)	N/A	N/A	DWS 3 Length (in)	N/A
N/A	Road 3 Slope (%)	N/A	N/A	DWS 3 Full Width?	N/A
N/A	Road 3 XSlope (%)	N/A	N/A	DWS 3 Offset (in)	N/A
Yes	Any Obstructions?	N/A	N/A	Storm Grate/Utility Hazard?	N/A
N/A	Obstruction Type		N/A	Storm Grate/Utility Type	
		N/A			N/A
N/A	Surface Condition	Good

Possible Solutions:

Remove & Replace Entire Refuge.
