Access Compliance Report

Public Rights-of-Way

(Island Curb Cuts)

Intersection ID: 30454	Main Street: SHALOM_PARK_DR	Cross Street: PROVIDENCE_RD	Location: NE
ADA ID: 83867D9EE75A	Curb Cut Type: MedianRefuge2	Initial Pass/Fail: Fail	Overall Compliance: No
Severity Score: 0			
Codes/Mitigation Info/Possible Solution		Field Measurements/Component Compliance

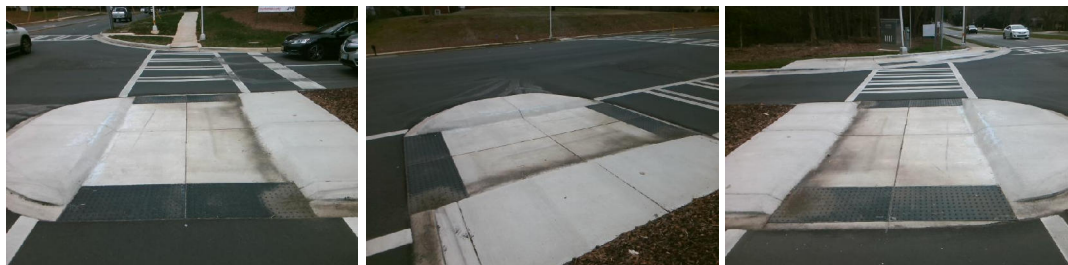
Compliance	Description	Data	Compliance	Description	Data
Yes	Refuge 1 Length (In)	79.0	N/A	Gutter 1 Ponding?	N/A
Yes	Refuge 1 Width (In)	94.0	N/A	Gutter 1 Lip Ht (In)	N/A
Yes	Refuge 1 Slope (%)	1.4	N/A	Gutter 1 Slope (%)	N/A
Yes	Refuge 1 X Slope (%)	2.9	N/A	Gutter 1 X Slope (%)	N/A
N/A	Painted X Walk1?	Yes	N/A	DWS 1 Provided?	N/A
N/A	X Walk 1 Direction	To NW	N/A	DWS 1 Contrast?	N/A
N/A	X Walk 1 Width (In)	111.0	N/A	DWS 1 Length (In)	N/A
N/A	Road 1 Slope (%)	2.5	N/A	DWS 1 Full Width?	N/A
N/A	Road 1 X Slope (%)	3.7	N/A	DWS 1 Offset (In)	N/A
Yes	Refuge 2 Length (In)	79.0	N/A	Gutter 2 Ponding?	N/A
Yes	Refuge 2 Width (In)	94.0	N/A	Gutter 2 Lip Ht (In)	N/A
Yes	Refuge 2 Slope (%)	0.3	N/A	Gutter 2 Slope (%)	N/A
Yes	Refuge 2 X Slope (%)	2.1	N/A	Gutter 2 X Slope (%)	N/A
N/A	Painted X Walk2?	Yes	N/A	DWS 2 Provided?	N/A
N/A	X Walk 2 Direction	To SE	N/A	DWS 2 Contrast?	N/A
N/A	X Walk 2 Width (In)	112.0	N/A	DWS 2 Length (In)	N/A

N/A	Road 2 Slope (%)	2.2	N/A	DWS 2 Full Width?	N/A
N/A	Road 2 X Slope (%)	2.0	N/A	DWS 2 Offset (In)	N/A
N/A	Refuge 3 Length (in)	N/A	N/A	Gutter 3 Ponding?	N/A
N/A	Refuge 3 Width (in)	N/A	N/A	Gutter 3 Lip Ht (in)	N/A
N/A	Refuge 3 Slope (%)	N/A	N/A	Gutter 3 Slope (%)	N/A
N/A	Refuge 3 XSlope (%)	N/A	N/A	Gutter 3 XSlope (%)	N/A
N/A	Painted X Walk3?	N/A	N/A	DWS 3 Provided?	N/A
N/A	X Walk 3 Direction	N/A	N/A	DWS 3 Contrast?	N/A
N/A	X Walk 3 Width (in)	N/A	N/A	DWS 3 Length (in)	N/A
N/A	Road 3 Slope (%)	N/A	N/A	DWS 3 Full Width?	N/A
N/A	Road 3 XSlope (%)	N/A	N/A	DWS 3 Offset (in)	N/A
Yes	Any Obstructions?	N/A	N/A	Storm Grate/Utility Hazard?	N/A
N/A	Obstruction Type		N/A	Storm Grate/Utility Type	
		N/A			N/A
N/A	Surface Condition	Good

Remove & Replace Entire Refuge.
