Access Compliance Report

Public Rights-of-Way

(Island Curb Cuts)

Intersection ID: 27490	Main Street: BALLANTYNE_COMMONS_PY	Cross Street: JOHNSTON_RD	Location: NE
ADA ID: 8449D2863E5E	Curb Cut Type: IslandRefuge3	Initial Pass/Fail: Fail	Overall Compliance: No
Codes/Mitigation Info/Possible Solution		Field Measurements/Component Compliance

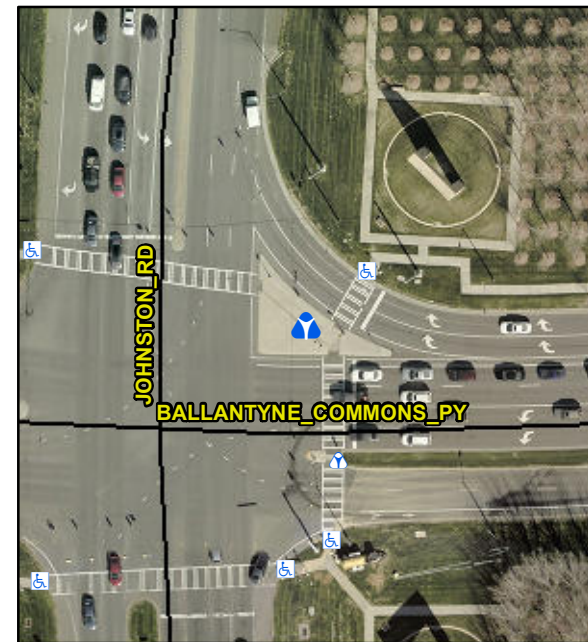
Compliance	Description	Data	Compliance	Description	Data
Yes	Refuge 1 Length (In)	60.0	N/A	Gutter 1 Ponding?	N/A
Yes	Refuge 1 Width (In)	70.0	N/A	Gutter 1 Lip Ht (In)	N/A
Yes	Refuge 1 Slope (%)	2.9	N/A	Gutter 1 Slope (%)	N/A
Yes	Refuge 1 X Slope (%)	2.1	N/A	Gutter 1 X Slope (%)	N/A
N/A	Painted X Walk1?	Yes	N/A	DWS 1 Provided?	N/A
N/A	X Walk 1 Direction	To S	N/A	DWS 1 Contrast?	N/A
N/A	X Walk 1 Width (In)	130.0	N/A	DWS 1 Length (In)	N/A
N/A	Road 1 Slope (%)	3.5	N/A	DWS 1 Full Width?	N/A
N/A	Road 1 X Slope (%)	2.1	N/A	DWS 1 Offset (In)	N/A
Yes	Refuge 2 Length (In)	27.0	N/A	Gutter 2 Ponding?	N/A
Yes	Refuge 2 Width (In)	72.0	N/A	Gutter 2 Lip Ht (In)	N/A
Yes	Refuge 2 Slope (%)	0.7	N/A	Gutter 2 Slope (%)	N/A
Yes	Refuge 2 X Slope (%)	2.5	N/A	Gutter 2 X Slope (%)	N/A
N/A	Painted X Walk2?	Yes	N/A	DWS 2 Provided?	N/A
N/A	X Walk 2 Direction	To NW	N/A	DWS 2 Contrast?	N/A
N/A	X Walk 2 Width (In)	120.0	N/A	DWS 2 Length (In)	N/A

N/A	Road 2 Slope (%)	2.1	N/A	DWS 2 Full Width?	N/A
N/A	Road 2 X Slope (%)	3.6	N/A	DWS 2 Offset (In)	N/A
Yes	Refuge 3 Length (in)	64.0	N/A	Gutter 3 Ponding?	N/A
Yes	Refuge 3 Width (in)	71.0	N/A	Gutter 3 Lip Ht (in)	N/A
Yes	Refuge 3 Slope (%)	4.6	N/A	Gutter 3 Slope (%)	N/A
Yes	Refuge 3 XSlope (%)	1.8	N/A	Gutter 3 XSlope (%)	N/A
N/A	Painted X Walk3?	Yes	N/A	DWS 3 Provided?	N/A
N/A	X Walk 3 Direction	To NE	N/A	DWS 3 Contrast?	N/A
N/A	X Walk 3 Width (in)	3.8	N/A	DWS 3 Length (in)	N/A
N/A	Road 3 Slope (%)	119.0	N/A	DWS 3 Full Width?	N/A
N/A	Road 3 XSlope (%)	1.4	N/A	DWS 3 Offset (in)	N/A
Yes	Any Obstructions?	N/A	N/A	Storm Grate/Utility Hazard?	N/A
N/A	Obstruction Type		N/A	Storm Grate/Utility Type	
		N/A			N/A
N/A	Surface Condition	Good

Remove & Replace Entire Refuge.
