Access Compliance Report

Public Rights-of-Way

(Island Curb Cuts)

Intersection ID: 12427	Main Street: W_STONEWALL_ST	Cross Street: S MINT ST	Location: S
ADA ID: 85606BC906AD	Curb Cut Type: IslandRefuge3	Initial Pass/Fail: Pass	Overall Compliance: No
Severity Score: 5.25			
Codes/Mitigation Info/Possible Solution		Field Measurements/Component Compliance

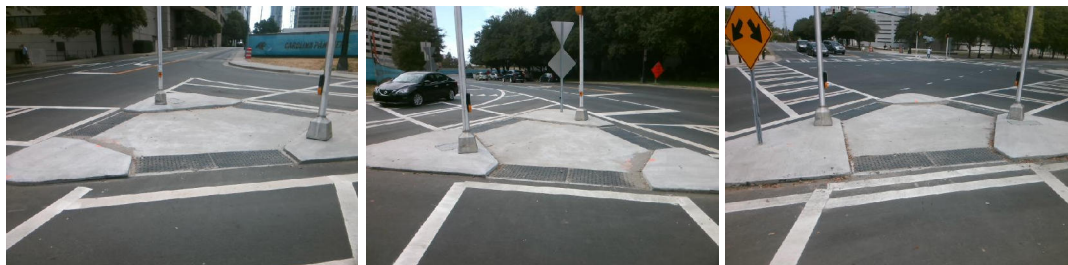
Compliance	Description	Data	Compliance	Description	Data
No	Refuge 1 Length (In)	24.0	Yes	Gutter 1 Ponding?	No
Yes	Refuge 1 Width (In)	99.0	Yes	Gutter 1 Lip Ht (In)	0.0
Yes	Refuge 1 Slope (%)	2.6	Yes	Gutter 1 Slope (%)	1.0
Yes	Refuge 1 X Slope (%)	1.1	Yes	Gutter 1 X Slope (%)	1.4
N/A	Painted X Walk1?	Yes	No	DWS 1 Provided?	Yes
N/A	X Walk 1 Direction	To NW	N/A	DWS 1 Contrast?	Yes
N/A	X Walk 1 Width (In)	109.0	N/A	DWS 1 Length (In)	24.0
N/A	Road 1 Slope (%)	1.7	N/A	DWS 1 Full Width?	Yes
N/A	Road 1 X Slope (%)	1.8	N/A	DWS 1 Offset (In)	3.0
No	Refuge 2 Length (In)	25.0	Yes	Gutter 2 Ponding?	No
Yes	Refuge 2 Width (In)	95.0	Yes	Gutter 2 Lip Ht (In)	0.0
Yes	Refuge 2 Slope (%)	1.7	Yes	Gutter 2 Slope (%)	3.0
Yes	Refuge 2 X Slope (%)	1.8	No	Gutter 2 X Slope (%)	3.0
N/A	Painted X Walk2?	Yes	No	DWS 2 Provided?	Yes
N/A	X Walk 2 Direction	To NE	N/A	DWS 2 Contrast?	Yes
N/A	X Walk 2 Width (In)	111.0	N/A	DWS 2 Length (In)	24.0

N/A	Road 2 Slope (%)	7.4	N/A	DWS 2 Full Width?	Yes
N/A	Road 2 X Slope (%)	1.5	N/A	DWS 2 Offset (In)	2.0
No	Refuge 3 Length (in)	19.0	Yes	Gutter 3 Ponding?	No
Yes	Refuge 3 Width (in)	98.0	Yes	Gutter 3 Lip Ht (in)	0.0
Yes	Refuge 3 Slope (%)	2.1	Yes	Gutter 3 Slope (%)	3.1
Yes	Refuge 3 XSlope (%)	0.8	No	Gutter 3 XSlope (%)	4.8
N/A	Painted X Walk3?	Yes	No	DWS 3 Provided?	Yes
N/A	X Walk 3 Direction	To S	N/A	DWS 3 Contrast?	Yes
N/A	X Walk 3 Width (in)	108.0	N/A	DWS 3 Length (in)	24.0
N/A	Road 3 Slope (%)	3.5	N/A	DWS 3 Full Width?	Yes
N/A	Road 3 XSlope (%)	2.2	N/A	DWS 3 Offset (in)	3.0
Yes	Any Obstructions?	N/A	N/A	Storm Grate/Utility Hazard?	No
N/A	Obstruction Type		N/A	Storm Grate/Utility Type	
		N/A			N/A
N/A	Surface Condition	Good

Remove & Replace Entire Refuge.
Remove & Replace Gutter.
