Access Compliance Report

Public Rights-of-Way

(Island Curb Cuts)

Intersection ID: 53165	Main Street: DIXIE_RIVER_RD	Cross Street: STYLE_LN	Location: W
ADA ID: 860AEA2EFC9F	Curb Cut Type: MedianRefuge2	Initial Pass/Fail: Fail	Overall Compliance: No
Codes/Mitigation Info/Possible Solution		Field Measurements/Component Compliance

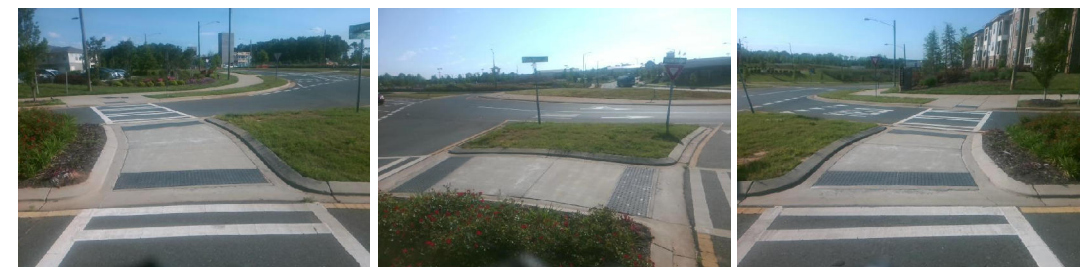
Compliance	Description	Data	Compliance	Description	Data
Yes	Refuge 1 Length (In)	94	N/A	Gutter 1 Ponding?	N/A
Yes	Refuge 1 Width (In)	115	N/A	Gutter 1 Lip Ht (In)	N/A
No	Refuge 1 Slope (%)	5.8	N/A	Gutter 1 Slope (%)	N/A
Yes	Refuge 1 X Slope (%)	2.7	N/A	Gutter 1 X Slope (%)	N/A
N/A	Painted X Walk1?	Yes	N/A	DWS 1 Provided?	N/A
N/A	X Walk 1 Direction	To S	N/A	DWS 1 Contrast?	N/A
N/A	X Walk 1 Width (In)	106	N/A	DWS 1 Length (In)	N/A
N/A	Road 1 Slope (%)	2.3	N/A	DWS 1 Full Width?	N/A
N/A	Road 1 X Slope (%)	0.6	N/A	DWS 1 Offset (In)	N/A
Yes	Refuge 2 Length (In)	94	N/A	Gutter 2 Ponding?	N/A
Yes	Refuge 2 Width (In)	115	N/A	Gutter 2 Lip Ht (In)	N/A
Yes	Refuge 2 Slope (%)	4.0	N/A	Gutter 2 Slope (%)	N/A
Yes	Refuge 2 X Slope (%)	0.1	N/A	Gutter 2 X Slope (%)	N/A
N/A	Painted X Walk2?	Yes	N/A	DWS 2 Provided?	N/A
N/A	X Walk 2 Direction	To N	N/A	DWS 2 Contrast?	N/A
N/A	X Walk 2 Width (In)	107	N/A	DWS 2 Length (In)	N/A
N/A	Road 2 Slope (%)	1.6	N/A	DWS 2 Full Width?	N/A

N/A	Road 2 X Slope (%)	0.3	N/A	DWS 2 Offset (In)	N/A
N/A	Refuge 3 Length (in)	N/A	N/A	Gutter 3 Ponding?	N/A
N/A	Refuge 3 Width (in)	N/A	N/A	Gutter 3 Lip Ht (in)	N/A
N/A	Refuge 3 Slope (%)	N/A	N/A	Gutter 3 Slope (%)	N/A
N/A	Refuge 3 XSlope (%)	N/A	N/A	Gutter 3 XSlope (%)	N/A
N/A	Painted X Walk3?	N/A	N/A	DWS 3 Provided?	N/A
N/A	X Walk 3 Direction	N/A	N/A	DWS 3 Contrast?	N/A
N/A	X Walk 3 Width (in)	N/A	N/A	DWS 3 Length (in)	N/A
N/A	Road 3 Slope (%)	N/A	N/A	DWS 3 Full Width?	N/A
N/A	Road 3 XSlope (%)	N/A	N/A	DWS 3 Offset (in)	N/A
Yes	Any Obstructions?	N/A	N/A	Storm Grate/Utility Hazard?	N/A
N/A	Obstruction Type		N/A	Storm Grate/Utility Type	
		N/A			N/A
N/A	Surface Condition	Good

Remove & Replace Entire Refuge.
