# Access Compliance Report

## Public Rights-of-Way

### (Island Curb Cuts)

Intersection ID: 10026082	Main Street: ENDAHVEN_LN	Cross Street: N/A	Location: NE
ADA ID: 86359BCC8DB5	Curb Cut Type: MedianRefuge2	Initial Pass/Fail: Pass	Overall Compliance: No
Severity Score: 0			
Codes/Mitigation Info/Possible Solution		Field Measurements/Component Compliance

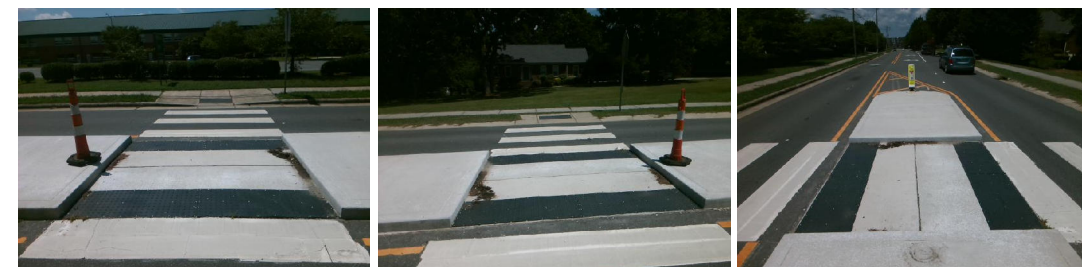
Compliance	Description	Data	Compliance	Description	Data
Yes	Refuge 1 Length (In)	53.5	Yes	Gutter 1 Ponding?	No
Yes	Refuge 1 Width (In)	119.5	Yes	Gutter 1 Lip Ht (In)	0.0
Yes	Refuge 1 Slope (%)	0.9	Yes	Gutter 1 Slope (%)	1.2
Yes	Refuge 1 X Slope (%)	0.1	Yes	Gutter 1 X Slope (%)	1.2
N/A	Painted X Walk1?	Yes	Yes	DWS 1 Provided?	Yes
N/A	X Walk 1 Direction	To SW	Yes	DWS 1 Contrast?	Yes
N/A	X Walk 1 Width (In)	121.0	Yes	DWS 1 Length (In)	24.0
N/A	Road 1 Slope (%)	1.0	Yes	DWS 1 Full Width?	Yes
N/A	Road 1 X Slope (%)	0.6	Yes	DWS 1 Offset (In)	0.0
Yes	Refuge 2 Length (In)	53.5	Yes	Gutter 2 Ponding?	No
Yes	Refuge 2 Width (In)	119.5	Yes	Gutter 2 Lip Ht (In)	0.0
Yes	Refuge 2 Slope (%)	1.2	Yes	Gutter 2 Slope (%)	2.5
Yes	Refuge 2 X Slope (%)	1.5	Yes	Gutter 2 X Slope (%)	0.6
N/A	Painted X Walk2?	Yes	Yes	DWS 2 Provided?	Yes
N/A	X Walk 2 Direction	To NE	No	DWS 2 Contrast?	N/A
N/A	X Walk 2 Width (In)	121.0	Yes	DWS 2 Length (In)	24.0

N/A	Road 2 Slope (%)	0.1	Yes	DWS 2 Full Width?	Yes
N/A	Road 2 X Slope (%)	2.0	Yes	DWS 2 Offset (In)	0.0
N/A	Refuge 3 Length (in)	N/A	N/A	Gutter 3 Ponding?	N/A
N/A	Refuge 3 Width (in)	N/A	N/A	Gutter 3 Lip Ht (in)	N/A
N/A	Refuge 3 Slope (%)	N/A	N/A	Gutter 3 Slope (%)	N/A
N/A	Refuge 3 XSlope (%)	N/A	N/A	Gutter 3 XSlope (%)	N/A
N/A	Painted X Walk3?	N/A	N/A	DWS 3 Provided?	N/A
N/A	X Walk 3 Direction	N/A	N/A	DWS 3 Contrast?	N/A
N/A	X Walk 3 Width (in)	N/A	N/A	DWS 3 Length (in)	N/A
N/A	Road 3 Slope (%)	N/A	N/A	DWS 3 Full Width?	N/A
N/A	Road 3 XSlope (%)	N/A	N/A	DWS 3 Offset (in)	N/A
Yes	Any Obstructions?	N/A	N/A	Storm Grate/Utility Hazard?	No
N/A	Obstruction Type		N/A	Storm Grate/Utility Type	
		N/A			N/A
N/A	Surface Condition	Good

**Remove & Replace Detectable Warning System.**
