# Access Compliance Report

## Public Rights-of-Way

### (Island Curb Cuts)

Intersection ID: 13442	Main Street: MORRIS_FIELD_DR	Cross Street: CPCC_HARRIS_CAMPUS_DR	Location: SE
ADA ID: 8654D35F9C07	Curb Cut Type: MedianRefuge2	Initial Pass/Fail: Fail	Overall Compliance: No
Codes/Mitigation Info/Possible Solution		Field Measurements/Component Compliance

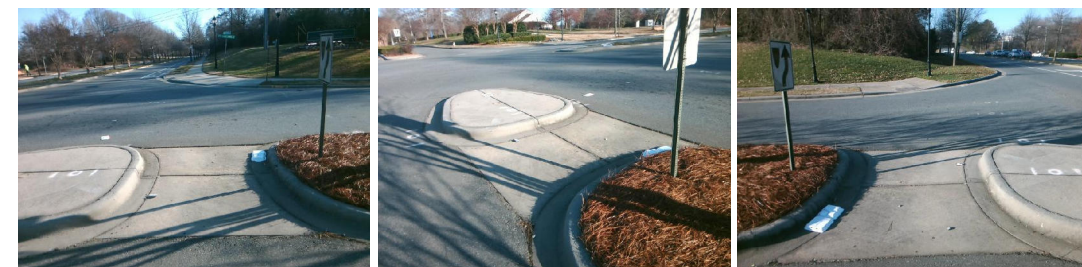
Compliance	Description	Data	Compliance	Description	Data
Yes	Refuge 1 Length (In)	56.0	N/A	Gutter 1 Ponding?	N/A
Yes	Refuge 1 Width (In)	60.0	N/A	Gutter 1 Lip Ht (In)	N/A
Yes	Refuge 1 Slope (%)	1.4	N/A	Gutter 1 Slope (%)	N/A
No	Refuge 1 X Slope (%)	8.6	N/A	Gutter 1 X Slope (%)	N/A
N/A	Painted X Walk1?	No	N/A	DWS 1 Provided?	N/A
N/A	X Walk 1 Direction	To NE	N/A	DWS 1 Contrast?	N/A
N/A	X Walk 1 Width (In)	N/A	N/A	DWS 1 Length (In)	N/A
N/A	Road 1 Slope (%)	4.4	N/A	DWS 1 Full Width?	N/A
N/A	Road 1 X Slope (%)	1.0	N/A	DWS 1 Offset (In)	N/A
Yes	Refuge 2 Length (In)	56.0	N/A	Gutter 2 Ponding?	N/A
Yes	Refuge 2 Width (In)	60.0	N/A	Gutter 2 Lip Ht (In)	N/A
Yes	Refuge 2 Slope (%)	2.0	N/A	Gutter 2 Slope (%)	N/A
No	Refuge 2 X Slope (%)	6.9	N/A	Gutter 2 X Slope (%)	N/A
N/A	Painted X Walk2?	No	N/A	DWS 2 Provided?	N/A
N/A	X Walk 2 Direction	To SW	N/A	DWS 2 Contrast?	N/A
N/A	X Walk 2 Width (In)	N/A	N/A	DWS 2 Length (In)	N/A

N/A	Road 2 Slope (%)	3.2	N/A	DWS 2 Full Width?	N/A
N/A	Road 2 X Slope (%)	2.5	N/A	DWS 2 Offset (In)	N/A
N/A	Refuge 3 Length (in)	N/A	N/A	Gutter 3 Ponding?	N/A
N/A	Refuge 3 Width (in)	N/A	N/A	Gutter 3 Lip Ht (in)	N/A
N/A	Refuge 3 Slope (%)	N/A	N/A	Gutter 3 Slope (%)	N/A
N/A	Refuge 3 XSlope (%)	N/A	N/A	Gutter 3 XSlope (%)	N/A
N/A	Painted X Walk3?	N/A	N/A	DWS 3 Provided?	N/A
N/A	X Walk 3 Direction	N/A	N/A	DWS 3 Contrast?	N/A
N/A	X Walk 3 Width (in)	N/A	N/A	DWS 3 Length (in)	N/A
N/A	Road 3 Slope (%)	N/A	N/A	DWS 3 Full Width?	N/A
N/A	Road 3 XSlope (%)	N/A	N/A	DWS 3 Offset (in)	N/A
Yes	Any Obstructions?	N/A	N/A	Storm Grate/Utility Hazard?	N/A
N/A	Obstruction Type		N/A	Storm Grate/Utility Type	
		N/A			N/A
N/A	Surface Condition	Good

**Remove & Replace Entire Refuge.**
