Access Compliance Report

Public Rights-of-Way

(Island Curb Cuts)

Intersection ID: 14741	Main Street: EAST_BV	Cross Street: PARK_RD	Location: SE
ADA ID: 87333C5A4743	Curb Cut Type: MedianRefuge2	Initial Pass/Fail: Pass	Overall Compliance: No
Severity Score: 0.25			
Codes/Mitigation Info/Possible Solution		Field Measurements/Component Compliance

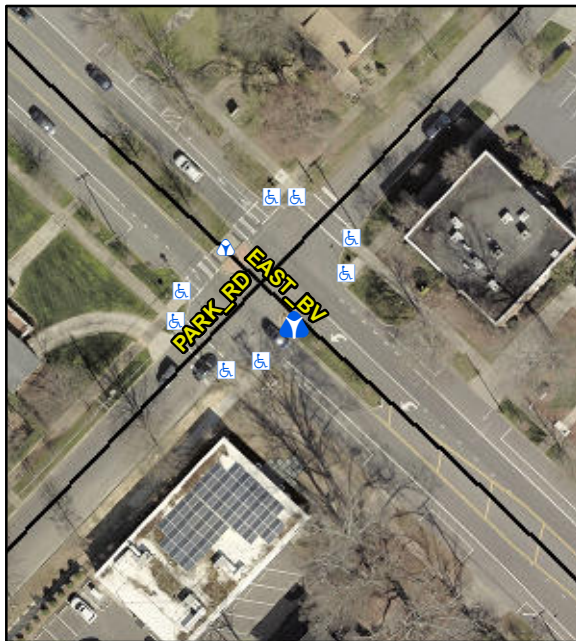
N/A	Road 2 Slope (%)	0.5	Yes	DWS 2 Full Width?	Yes
N/A	Road 2 X Slope (%)	1.8	No	DWS 2 Offset (In)	6.0
N/A	Refuge 3 Length (in)	N/A	N/A	Gutter 3 Ponding?	N/A
N/A	Refuge 3 Width (in)	N/A	N/A	Gutter 3 Lip Ht (in)	N/A
N/A	Refuge 3 Slope (%)	N/A	N/A	Gutter 3 Slope (%)	N/A
N/A	Refuge 3 XSlope (%)	N/A	N/A	Gutter 3 XSlope (%)	N/A
N/A	Painted X Walk3?	N/A	N/A	DWS 3 Provided?	N/A
N/A	X Walk 3 Direction	N/A	N/A	DWS 3 Contrast?	N/A
N/A	X Walk 3 Width (in)	N/A	N/A	DWS 3 Length (in)	N/A
N/A	Road 3 Slope (%)	N/A	N/A	DWS 3 Full Width?	N/A
N/A	Road 3 XSlope (%)	N/A	N/A	DWS 3 Offset (in)	N/A
Yes	Any Obstructions?	N/A	N/A	Storm Grate/Utility Hazard?	No
N/A	Obstruction Type		N/A	Storm Grate/Utility Type	
		N/A			N/A
N/A	Surface Condition	Good

Remove & Replace Detectable Warning System.
