Access Compliance Report

Public Rights-of-Way

(Island Curb Cuts)

Intersection ID: 10033070	Main Street: NORTH_COMMUNITY_HOUSE_RD	Cross Street: N/A	Location: S
ADA ID: 87E8376D63E3	Curb Cut Type: MedianRefuge2	Initial Pass/Fail: Pass	Overall Compliance: No
Codes/Mitigation Info/Possible Solution		Field Measurements/Component Compliance

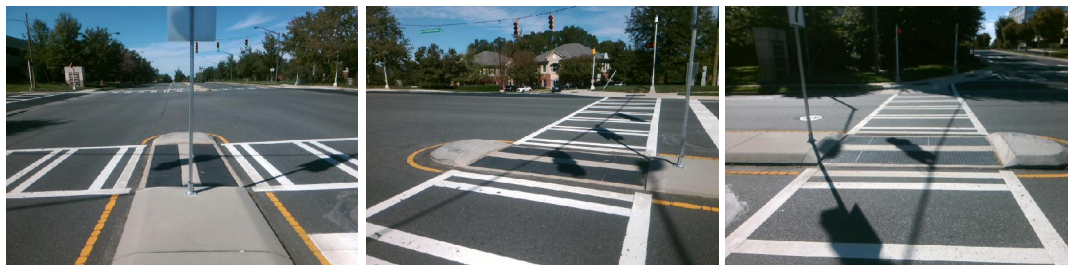
Compliance	Description	Data	Compliance	Description	Data
No	Refuge 1 Length (In)	34.0	Yes	Gutter 1 Ponding?	No
Yes	Refuge 1 Width (In)	119.0	Yes	Gutter 1 Lip Ht (In)	0.0
Yes	Refuge 1 Slope (%)	3.6	Yes	Gutter 1 Slope (%)	0.2
Yes	Refuge 1 X Slope (%)	0.6	Yes	Gutter 1 X Slope (%)	1.0
N/A	Painted X Walk1?	Yes	No	DWS 1 Provided?	Yes
N/A	X Walk 1 Direction	To E	N/A	DWS 1 Contrast?	Yes
N/A	X Walk 1 Width (In)	127.5	N/A	DWS 1 Length (In)	24.0
N/A	Road 1 Slope (%)	1.3	N/A	DWS 1 Full Width?	Yes
N/A	Road 1 X Slope (%)	2.6	N/A	DWS 1 Offset (In)	3.5
No	Refuge 2 Length (In)	34.0	Yes	Gutter 2 Ponding?	No
Yes	Refuge 2 Width (In)	119.0	Yes	Gutter 2 Lip Ht (In)	0.0
Yes	Refuge 2 Slope (%)	2.3	Yes	Gutter 2 Slope (%)	0.6
Yes	Refuge 2 X Slope (%)	0.5	Yes	Gutter 2 X Slope (%)	1.4
N/A	Painted X Walk2?	Yes	No	DWS 2 Provided?	Yes
N/A	X Walk 2 Direction	To W	N/A	DWS 2 Contrast?	Yes
N/A	X Walk 2 Width (In)	128.0	N/A	DWS 2 Length (In)	24.5

Remove & Replace Entire Refuge.
